PATTERNS OF STRUCTURAL FAILURE IN MONTEREY PINE

by Roger J. Edberg, Alison M. Berry and Laurence R. Costello

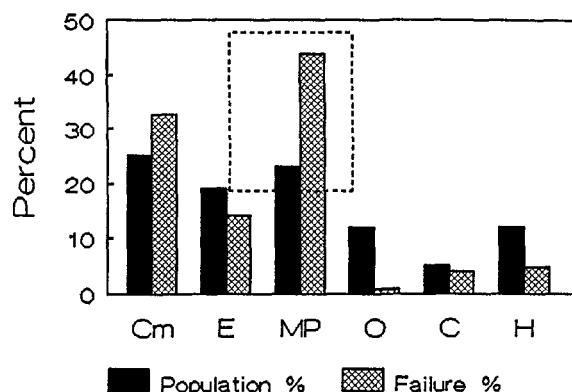
Monterey pines made up 23% of the Golden Gate Park tree population (1980 survey), yet 44% of all reported failures from Golden Gate Park were Monterey pine, substantially higher than the percentage in the park population (Fig. 1). Monterey cypress (*Cupressus macrocarpa*) failed at a rate somewhat higher than its percentage in the park population, while eucalyptus and oak species were reported to fail at a rate approximately equal to, or below their percentage in the population. When additional categories were created, i.e. "other conifers" (all conifers excluding

Figure 1. Comparison of tree failure frequency and population composition in Golden Gate Park, San Francisco, CA (CM = *Cupressus macrocarpa*, E = Eucalyptus species, MP = Monterey pine, O = oak species, C = conifers, H = other hardwoods).

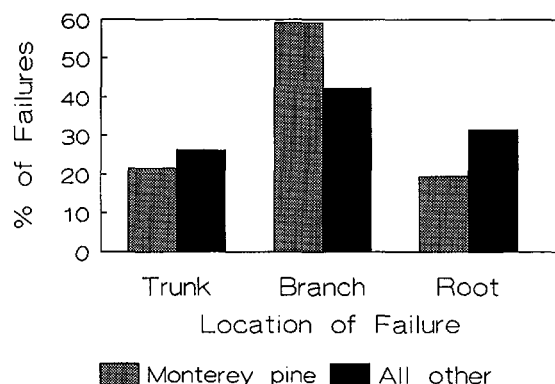
Characteristics of failure - branch. Monterey pine failures (Golden Gate Park and other combined) occurred most frequently at the branch (59%; Figure 2). Branch failures also form the largest category for all other species ("all other"). However, the frequency of branch failure for Monterey pine is significantly greater than for other species (chi-squared, $P=.00$). The sample population was greatly influenced by the predominance of reports from Golden Gate Park trees. Still, the branch failure rate for Monterey pine trees reported from other areas outside the park was significantly higher than that for all other trees in the database grouped together (51% vs 42%, chi-squared, $P=.03$) (Table 1).

Figure 2. Type of failure by location on the tree (trunk, branch, or root). Comparison of Monterey pine and all other trees in the database.

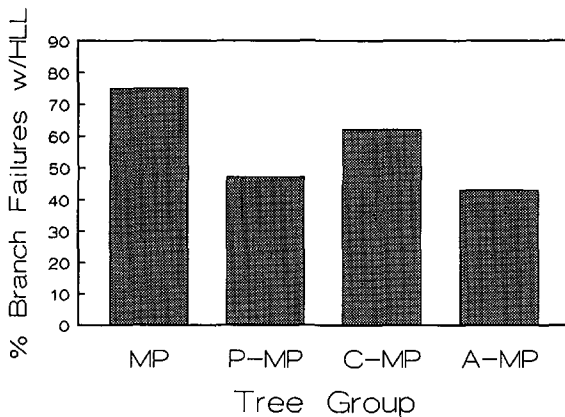
Heavy lateral limbs (HLL) were associated with 75% of all Monterey pine branch failures (MP, in Figure 4). This is nearly double the rate of association of heavy lateral limbs with branch failures for all other species as a group, excluding Monterey pine (43%, A-MP). Other pine species (P-MP) and other conifers in general as a group (C-MP) also

had lower rates of association (47% and 61% respectively). The high association of heavy lateral limbs with Monterey pine branch failure was consistent for failure reports from Golden Gate Park, and from other locations (Table 1). Surprisingly, the average branch diameter for HLL-associated failures was only 12". Long branches, branches with a heavy foliage load, and branches with a heavy cone load may have been included in this category for Monterey pine.

Figure 4. Heavy lateral limbs (HLL) as a structural defect associated with failure. Comparison of Monterey pine (MP) with other pines (P-MP), all conifers except Monterey pine (C-MP), and all other trees in the database (A-MP).

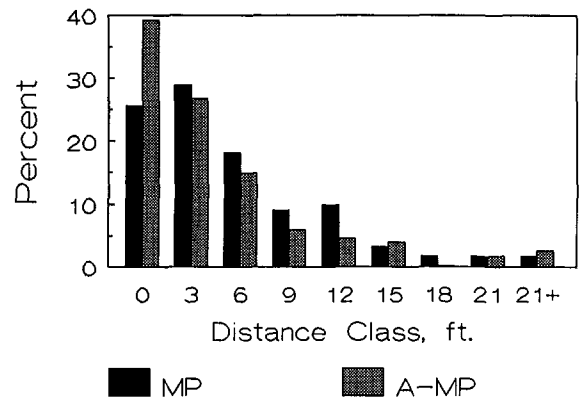
The location of branch failure ranged from the point of attachment with the main trunk to 25 feet out on the branch (Figure 5). Failure occurred flush with the trunk in 26% of all Monterey pine (MP) branch failure reports, while 74% occurred away from the point of attachment. This pattern suggests that most Monterey pine branch failures are not the result of a weak attachment but rather arise from some problem with wood strength or load distribution. Branch failures for all other species (A-MP) in the database grouped together occurred at the attachment in 39% of the reports and out on the branch 61% of the time. A cross-tabulation of branch failures at the attachment or not between Monterey pine and all other species as a group results in a chi-squared probability of .05.

Figure 5. Branch failures: Distance of break site from point of attachment to trunk (attachment = 0 ft., 1-3 ft. class = 3, 4-6 ft class = 6, etc.). Frequency of branch failures per distance class for Monterey pine (MP) and all other species combined (A-MP).

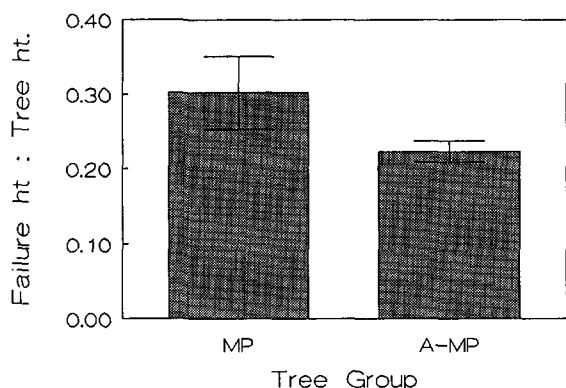
Trunk failures. Monterey pine trunk failures occurred relatively higher on the trunk than was typical for other trees in the database. The ratio of the height of trunk failure to the height of the tree for Monterey pine (.30) was greater than the mean for all other species combined as a group (.22, Figure 6). The ratio of the height of trunk failure to the height of the tree was used rather than failure height alone to compensate for the fact that Monterey pine is, on the average, a taller tree than most other landscape species in the database. The difference was significant at the 5% level for Monterey pine vs. all other species in an unpaired t -test.

Figure 6. Ratio of trunk failure height (height above ground where failure occurred) to total height of tree. Comparison of Monterey pine (MP) with all other trees in the database (A-MP).

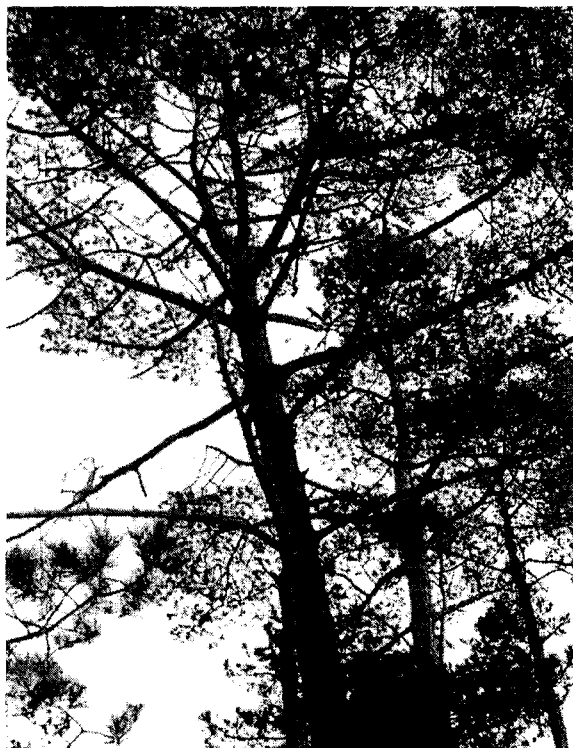
Figure 7. Typical limb architecture of Monterey pine from native stand in Monterey, CA.

Canopies with branches high on the trunk were common to both groups. Branches of trees in native stands had typical upper canopy branch diameters approximately one-half that of the trunk (Figure 7). In contrast, park trees commonly had

The lower trunk of the native Monterey pines had few branches (Figure 7), apparently as a result of shading out from earlier high stand densities. Park trees often had large diameter scaffold limbs (Figure 8) originating along the lower trunk (or pruning wounds indicating their previous presence).

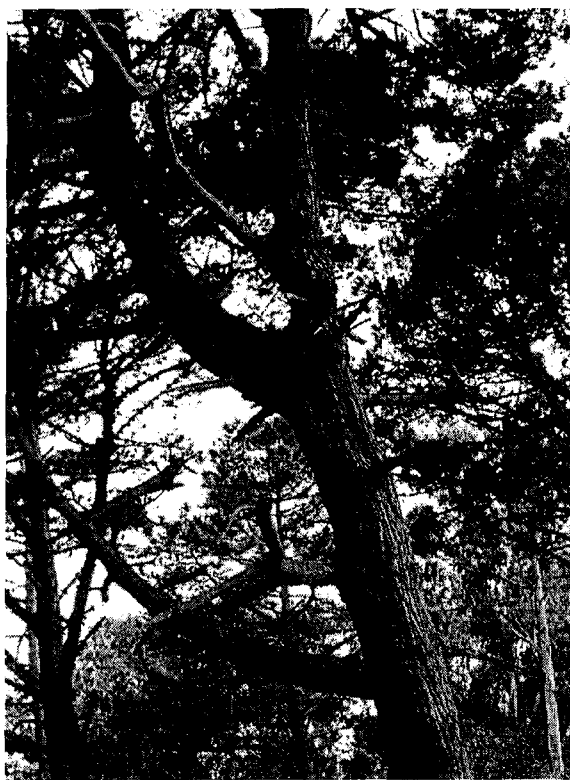
Figure 8. Heavy lateral limb of Monterey pine from Golden Gate Park, CA.

one to several lateral limbs (or codominant stems) whose diameter approached or exceeded that of the trunk diameter (Figure 8). The foliage appeared to be less dense in the native stands, possibly due to the shallow soil system, intermittent drought, and less nutrient availability. In both native stands and urban plantings, branch breakage seemed to occur most often out on the limb rather than at the trunk. Stubs left along the trunk were plentiful in both groups, generally 1 to 4 feet long. Several of those examined were broken at a dead secondary branch insertion point.

Arborists may reduce the incidence of heavy lateral limbs, codominant stems, and deformed trunks through careful attention to soil nutrition, particularly avoidance of excessive nitrogen (12). Interestingly, during the early years of tree establishment in Golden Gate Park, situated on a sand dune based soil, there was extensive use of "street sweepings" — including manure from the horse population in San Francisco at the time — as a soil amendment (4). This may have created site conditions conducive to development of large limbs and weak wood.
