A Conservation Plan
For Pine Creek
and
Eagle Lake Rainbow Trout
Lassen County
California

Under Contract with Honey Lake Valley Resource Conservation District

June 2007

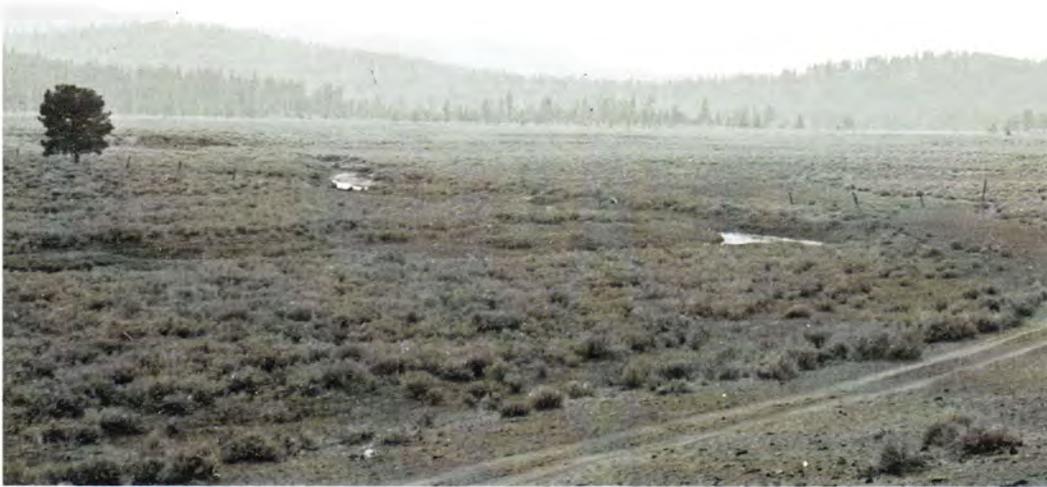
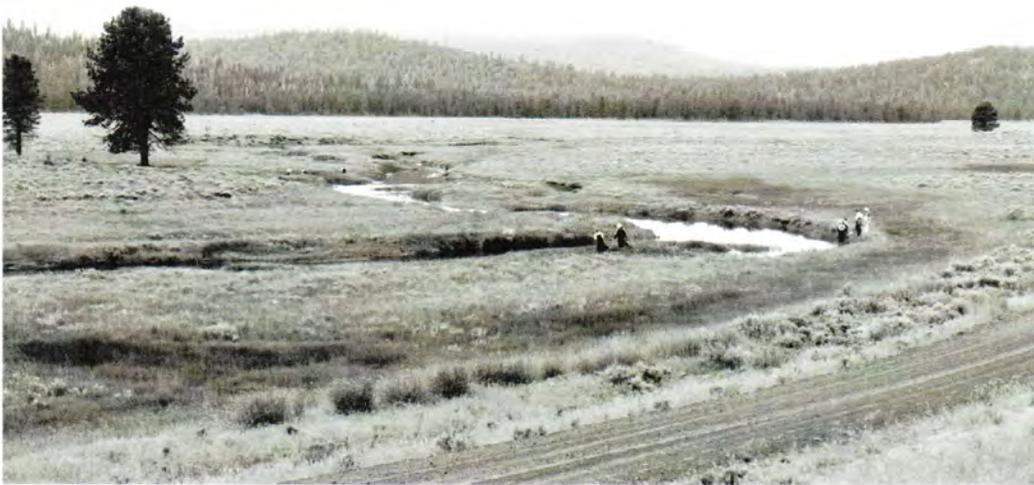
Figure 1. McCoy section of Pine Creek. Top, 1936, bottom, 1998.

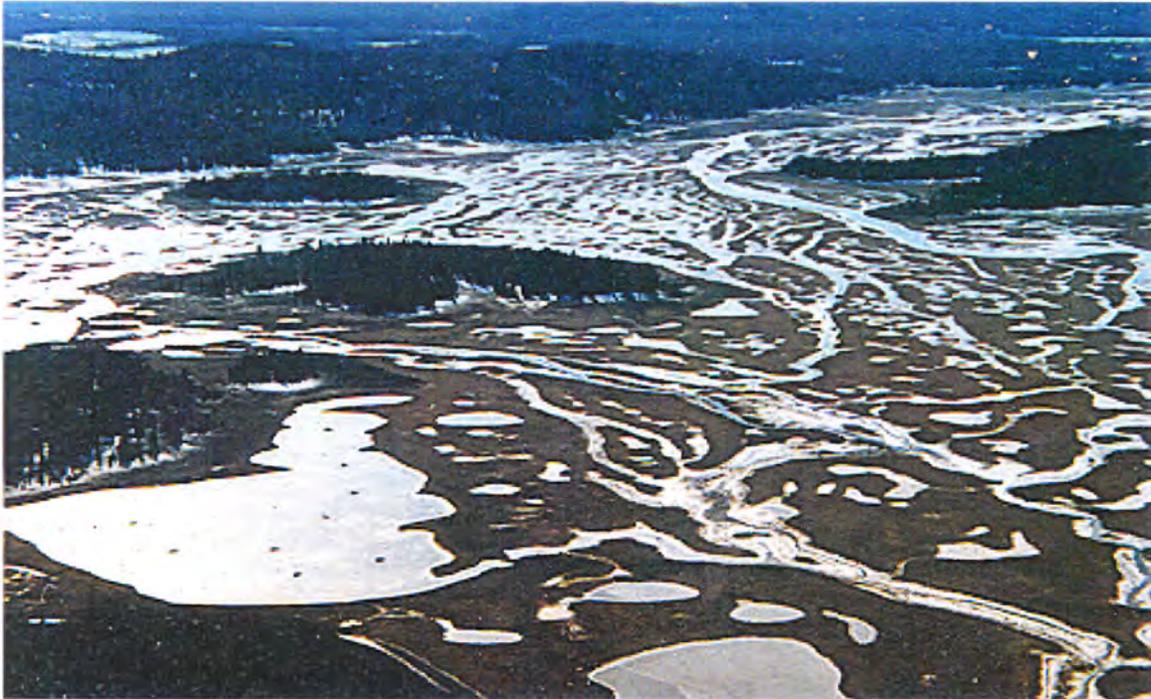
Figure 2. Aerial view of Pine Creek Valley after New Years flooding in 1997.
