Humboldt Redwood  
COMPANY, LLC

# **HRC Road Upgrade and Decommissioning**

**About the program, and  
Does it help water quality?**

Restoration Workshop  
May, 2011

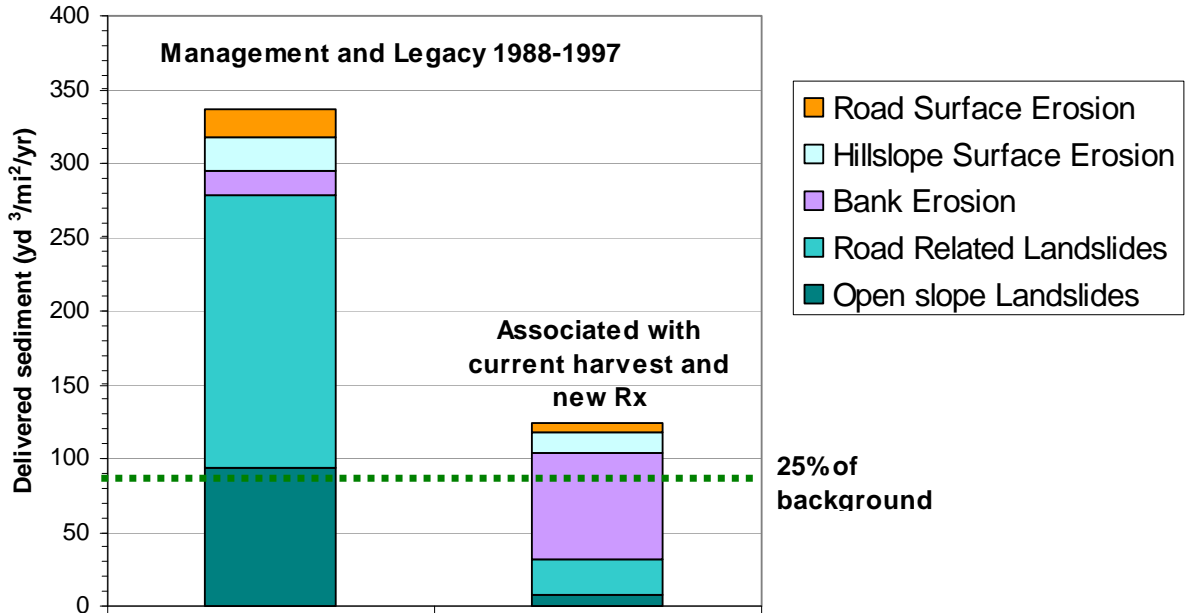
## Management-Related Sediment Elk River

# Ecologic Goal

Prevent	<ul style="list-style-type: none"> <li>➤ LS Avoidance on unstable terrain</li> <li>➤ Repair roads</li> </ul>
Minimize	<ul style="list-style-type: none"> <li>➤ Best management practices</li> <li>➤ Site specific Rx</li> </ul>
Restore	<ul style="list-style-type: none"> <li>➤ Road restoration and decommissioning</li> <li>➤ Legacy site cleanup</li> </ul>

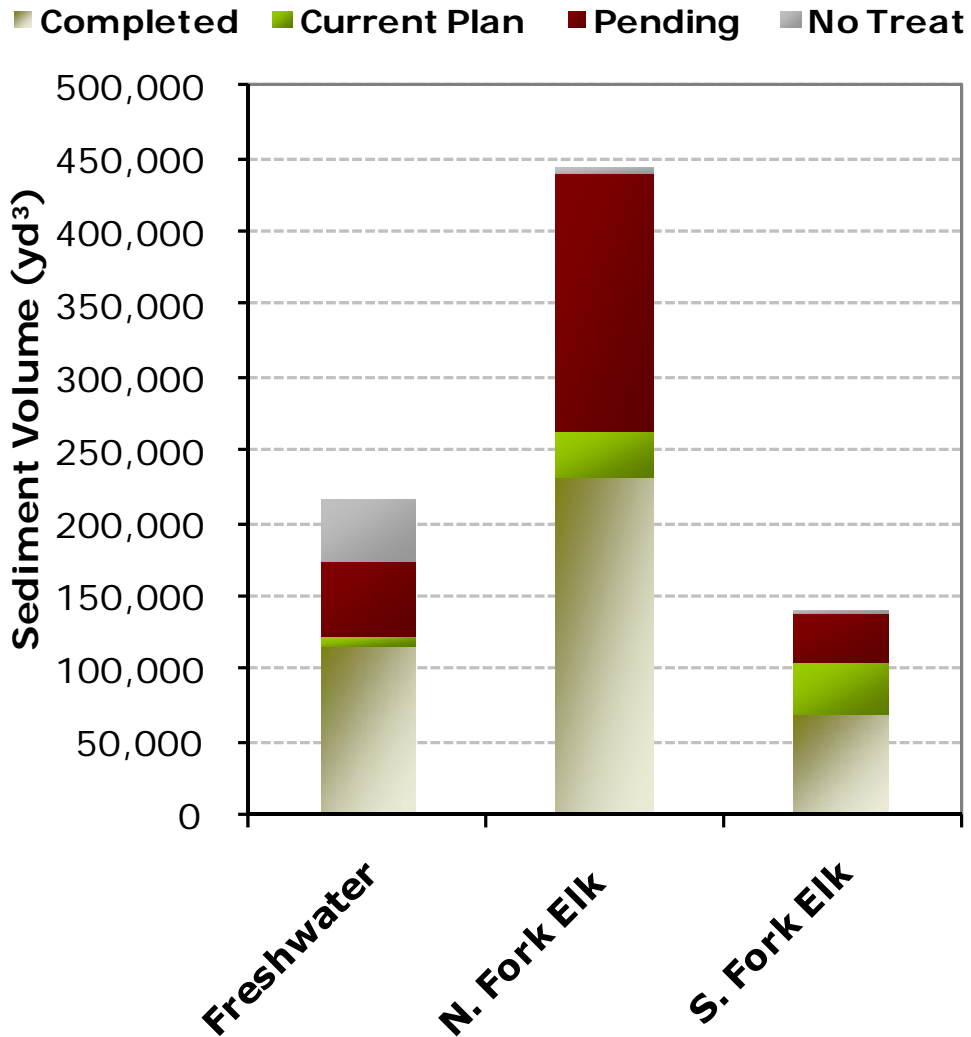
## Road Sediment Site Progress

# Inventoried Sites

**720,000 cubic yards—  
1 million tons**

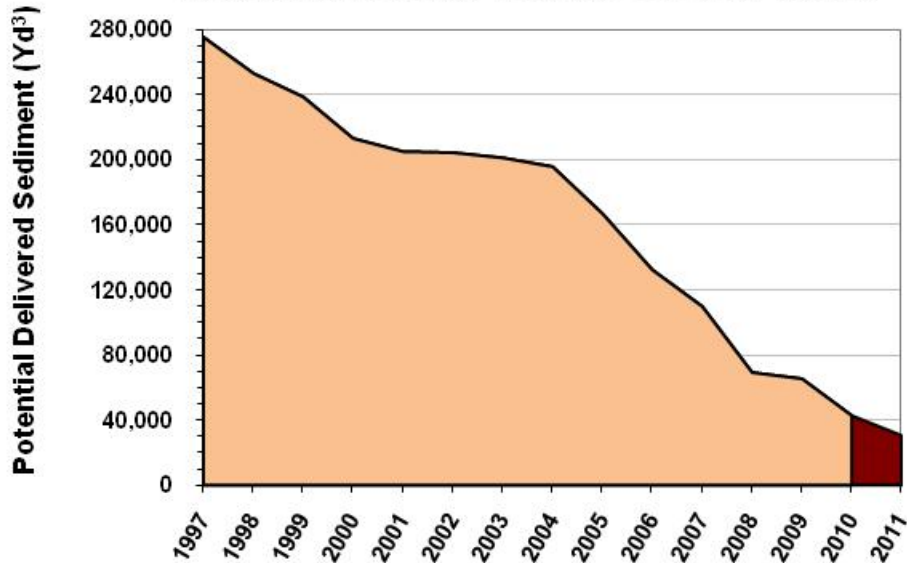
**N. Fork Elk River**  
**Progress in Reducing Treatable Sediment Volume**

# Progress to Date

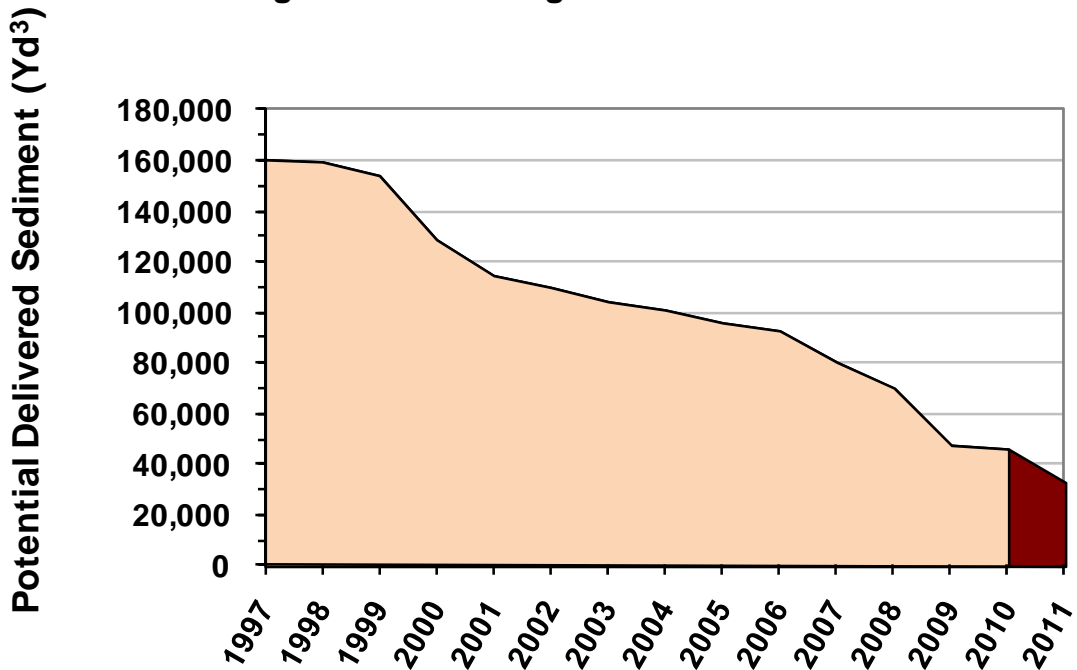
**Freshwater Creek**  
Progress in Reducing Treatable Sediment Volume

# Progress to Date

## Freshwater

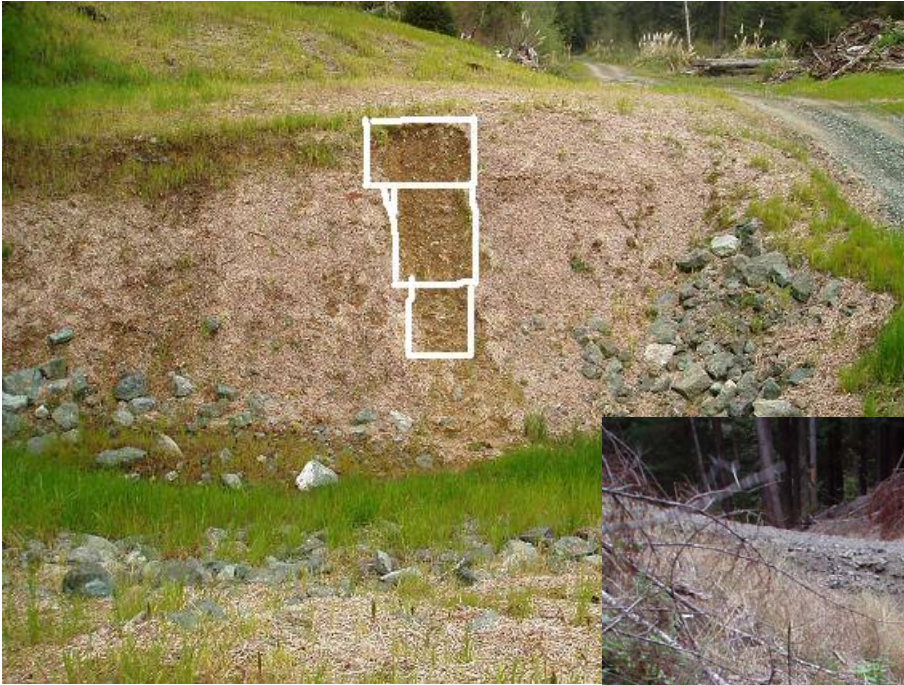
## Explanation of Method

# Erosion After Site Construction

4.90 Yd<sup>3</sup>

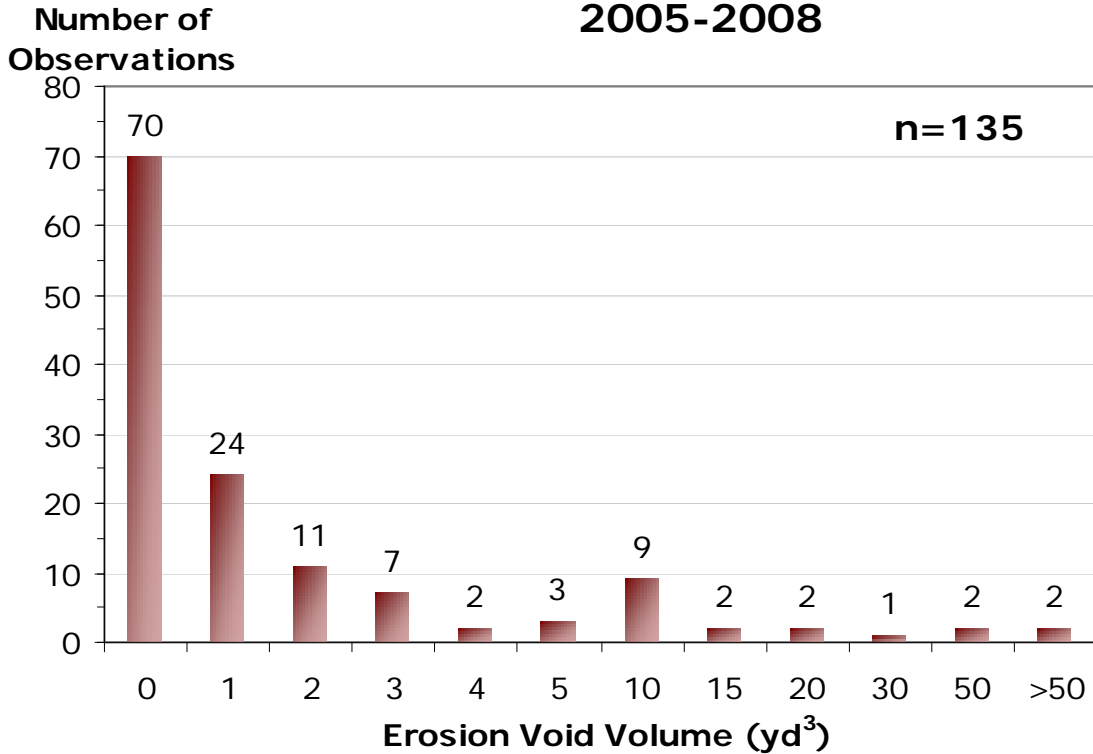
## Post Activity Erosion Volume Per Site 2005-2008

# Erosion After Site Construction

Yds Saved	Yds Eroded	
Erosion Study	70,074	441.0	
		0.6%	----- proportion of saved later eroded
Study observed		24%	sites
		33%	saved sediment

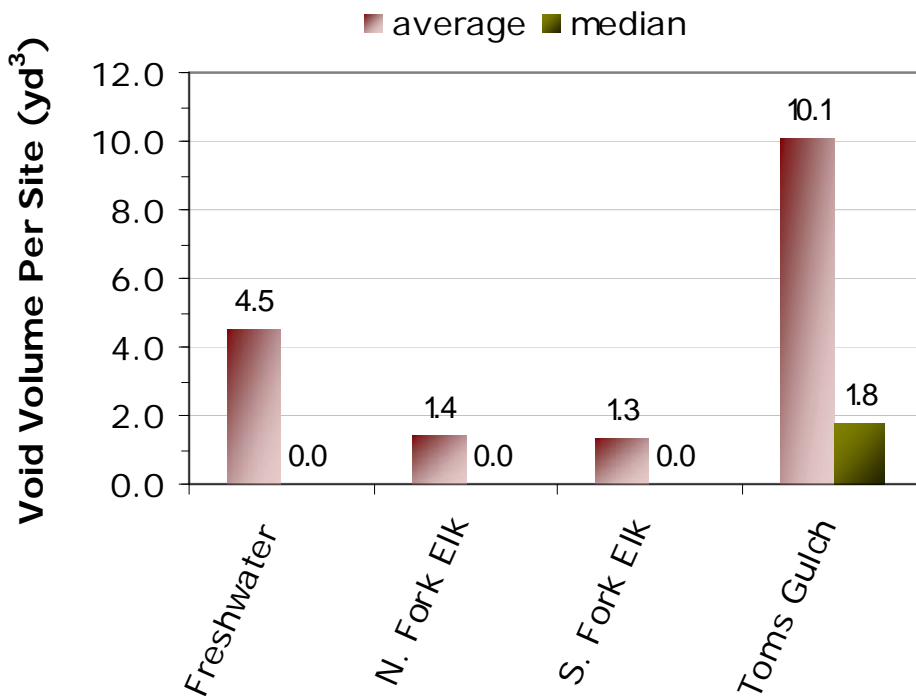
## Post Activity Erosion Average Per Site

# Average Erosion by Watershed

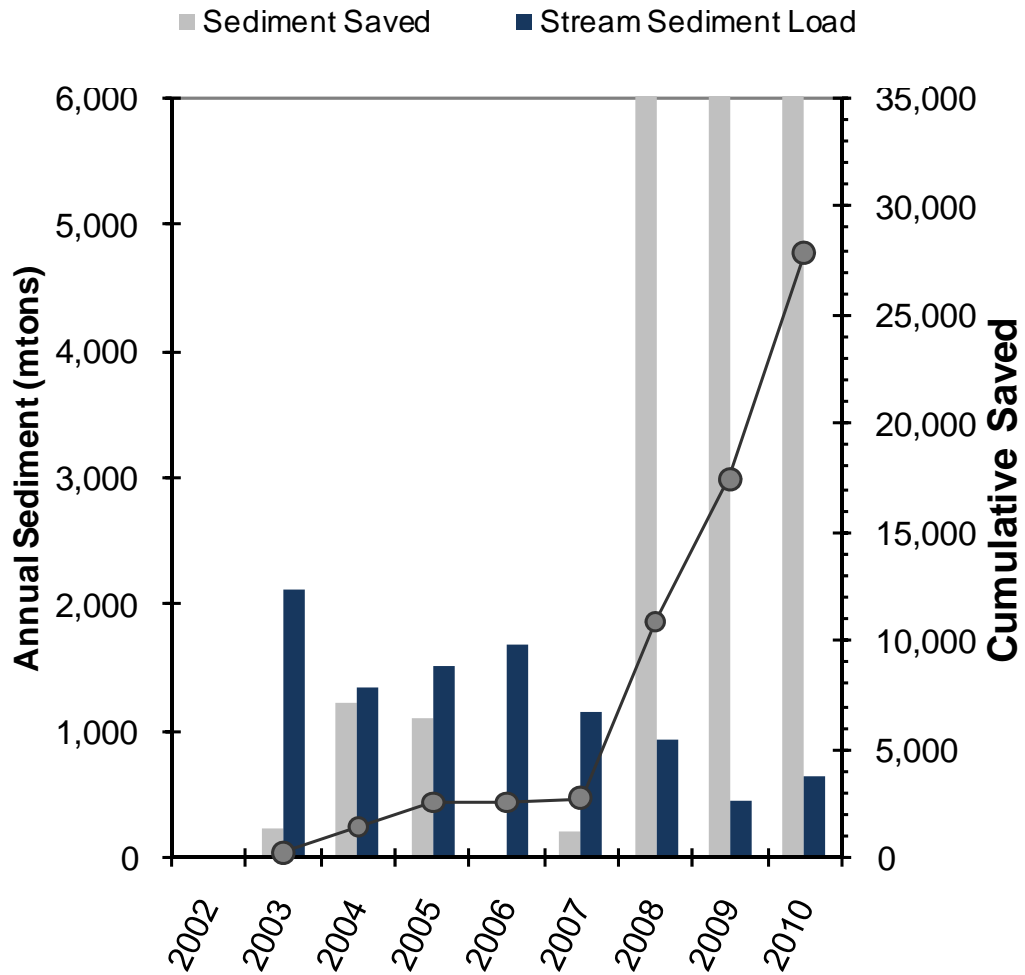
## Cloney Gulch During Stream Monitoring Period

# Effect on Water Quality— Cloney Gulch

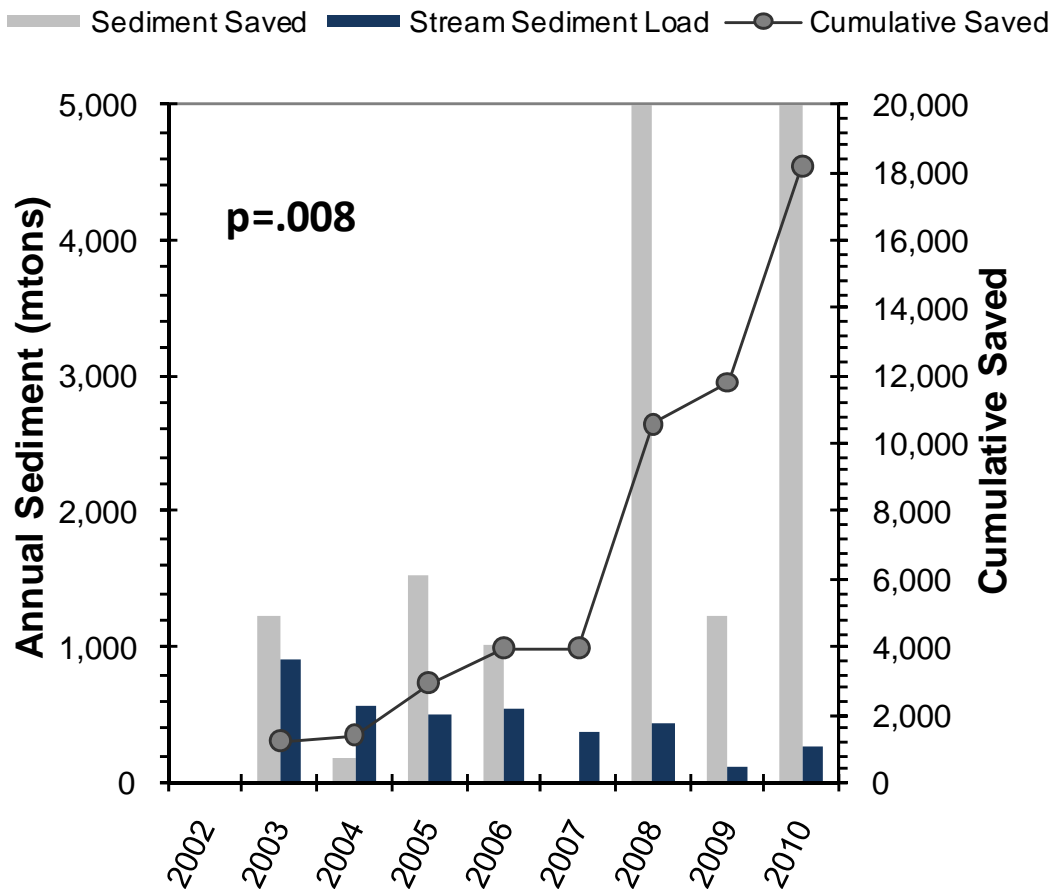
## McCready Gulch During Stream Monitoring Period

# Effect on Water Quality -- McCready Gulch

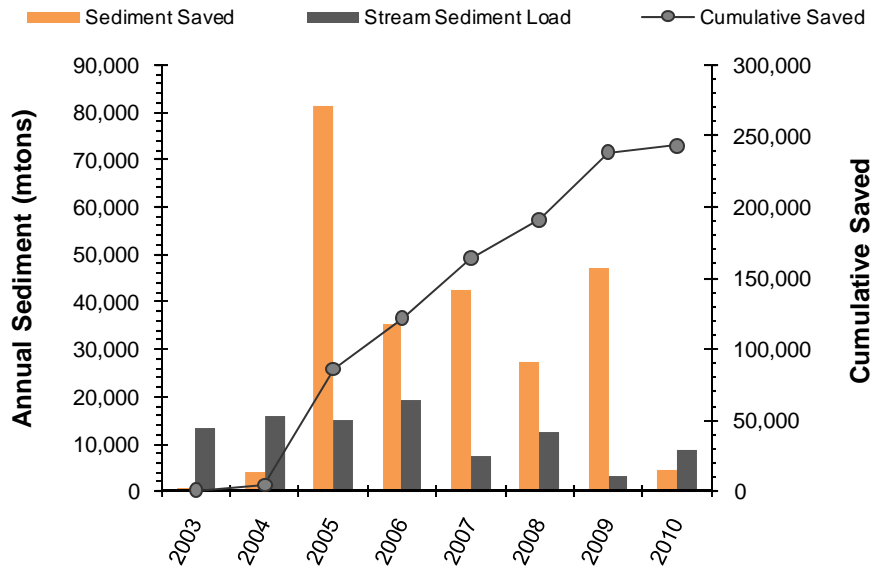
**Total N. Fork Watershed  
During Stream Monitoring Period**

# Effect on Water Quality -- N. Fork Elk River

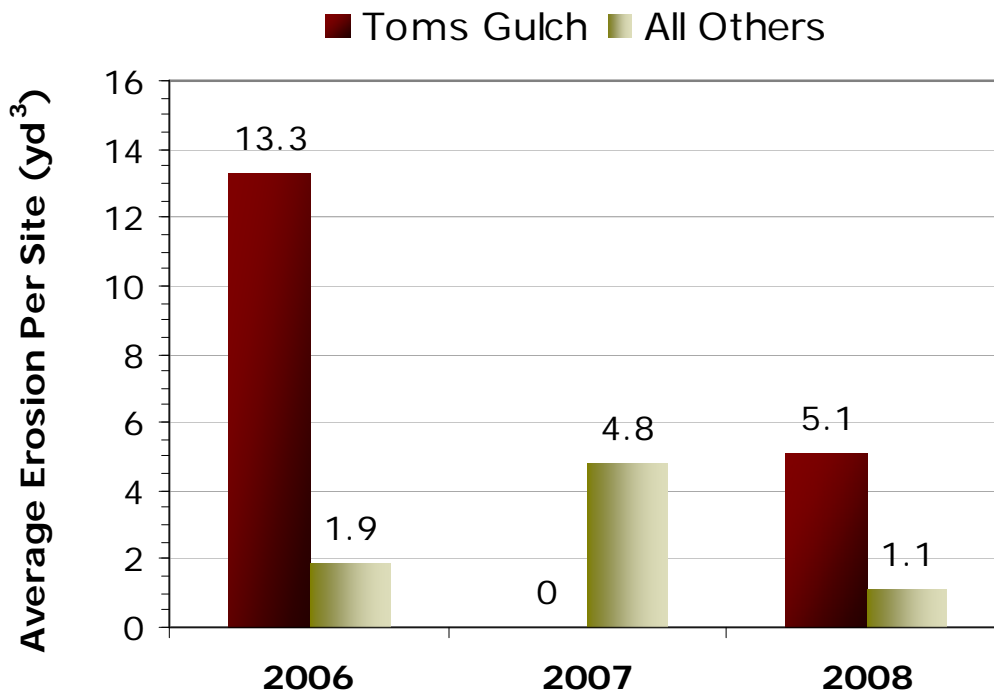
Comparing Toms Gulch to All Other Sites

# Toms Gulch has been more of a problem generally

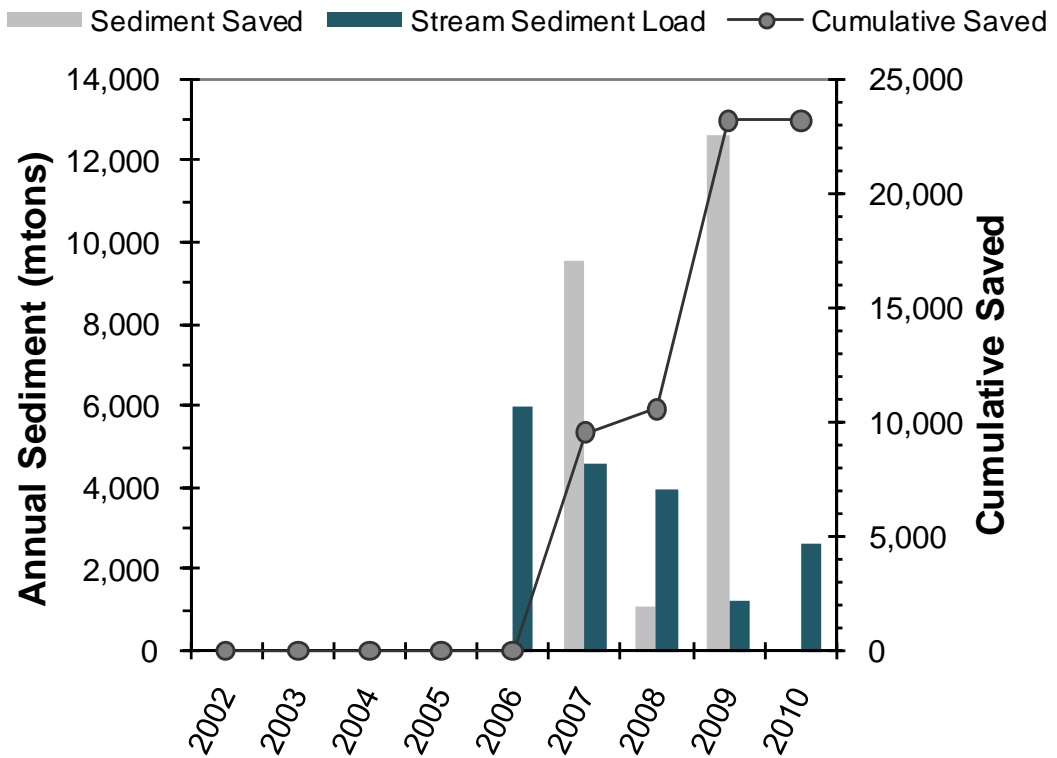
## Tom's Gulch During Stream Monitoring Period

# Water Quality—Toms Gulch

**Despite more erosion following construction, water quality has been improving**
