Water Quality Response to the Angora Fire, Lake Tahoe, CA

Angora Fire Science Symposium

June 23, 2017

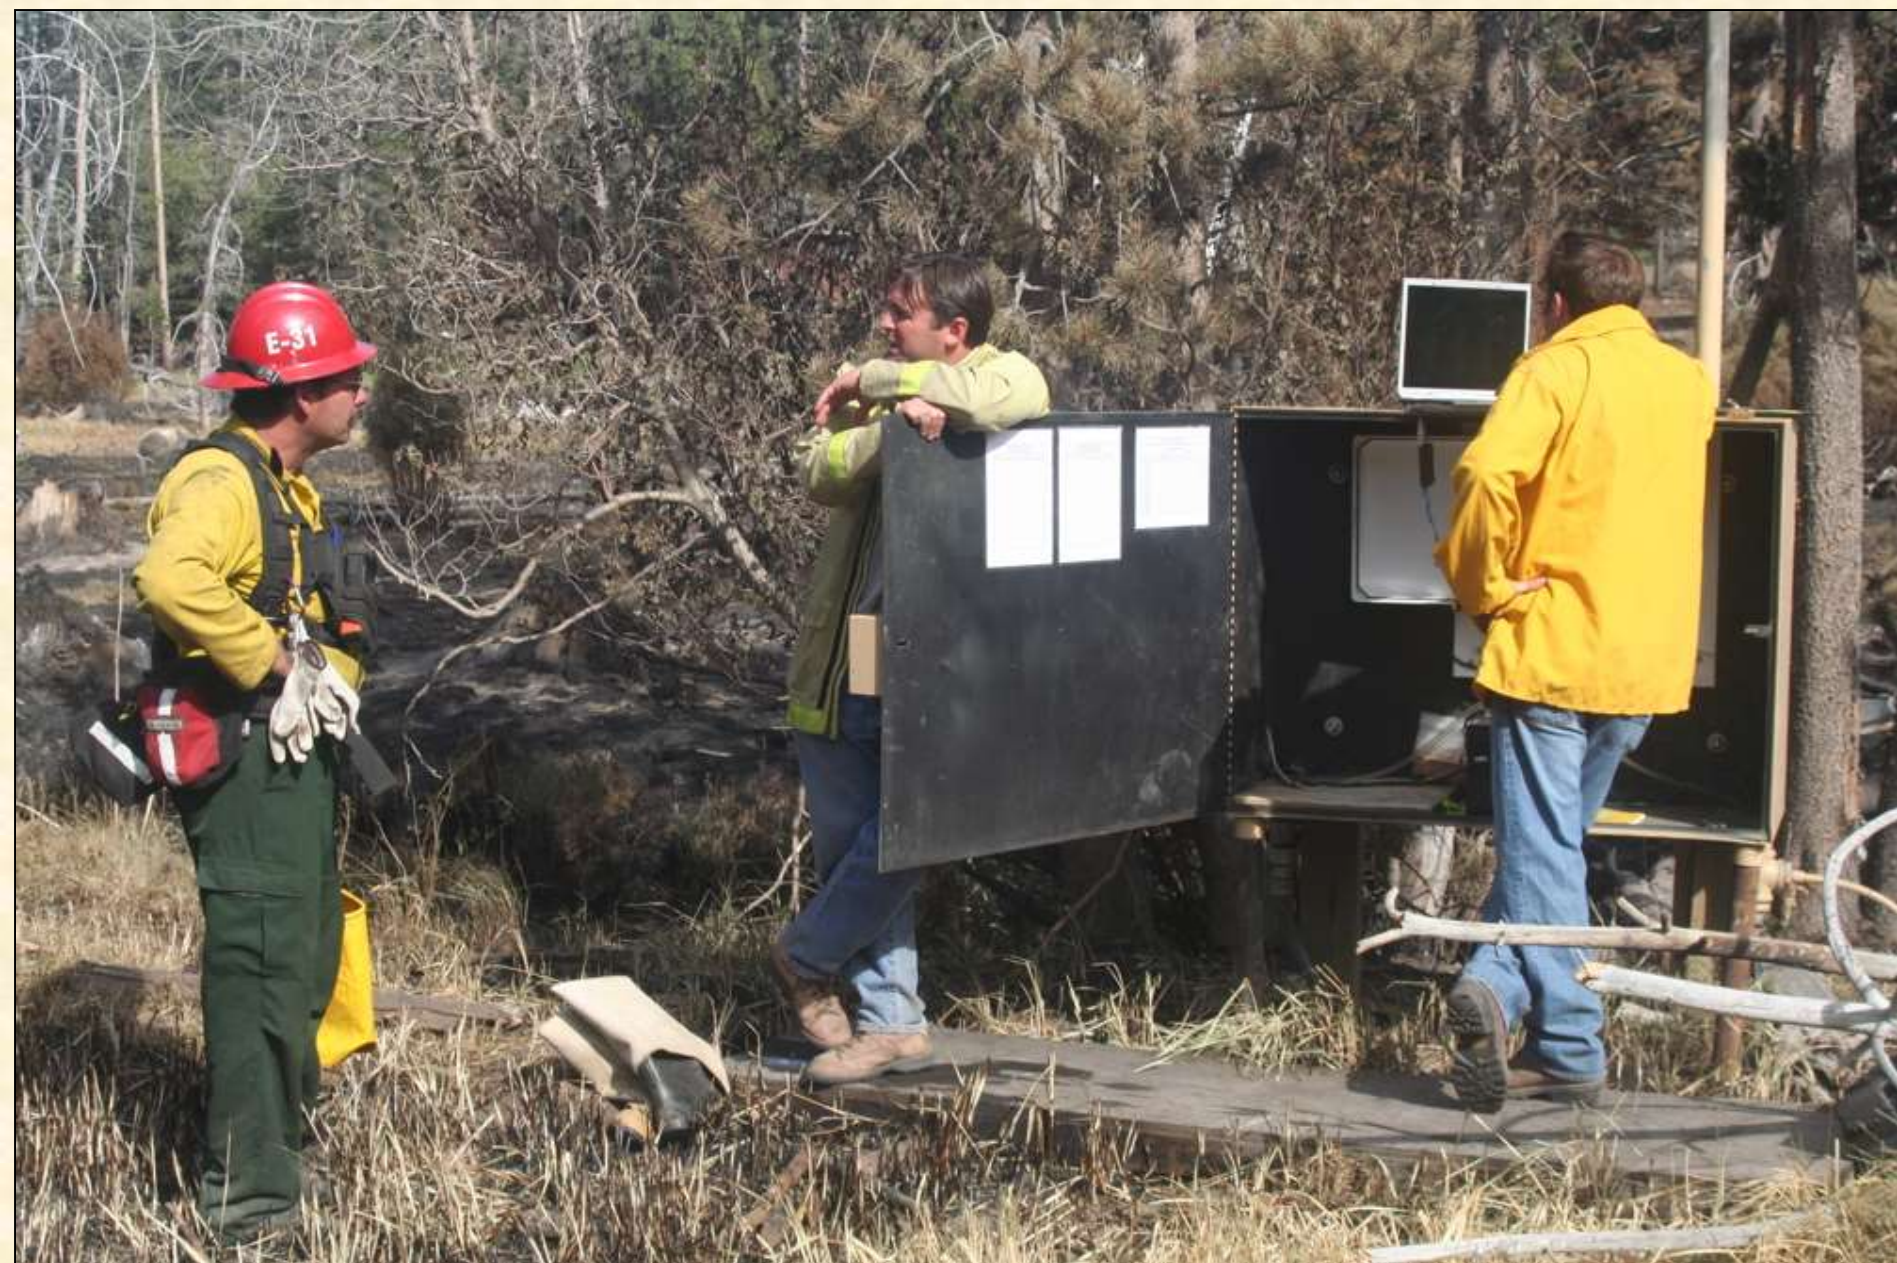
Installing Monitoring Equipment at Upper Angora Creek Site

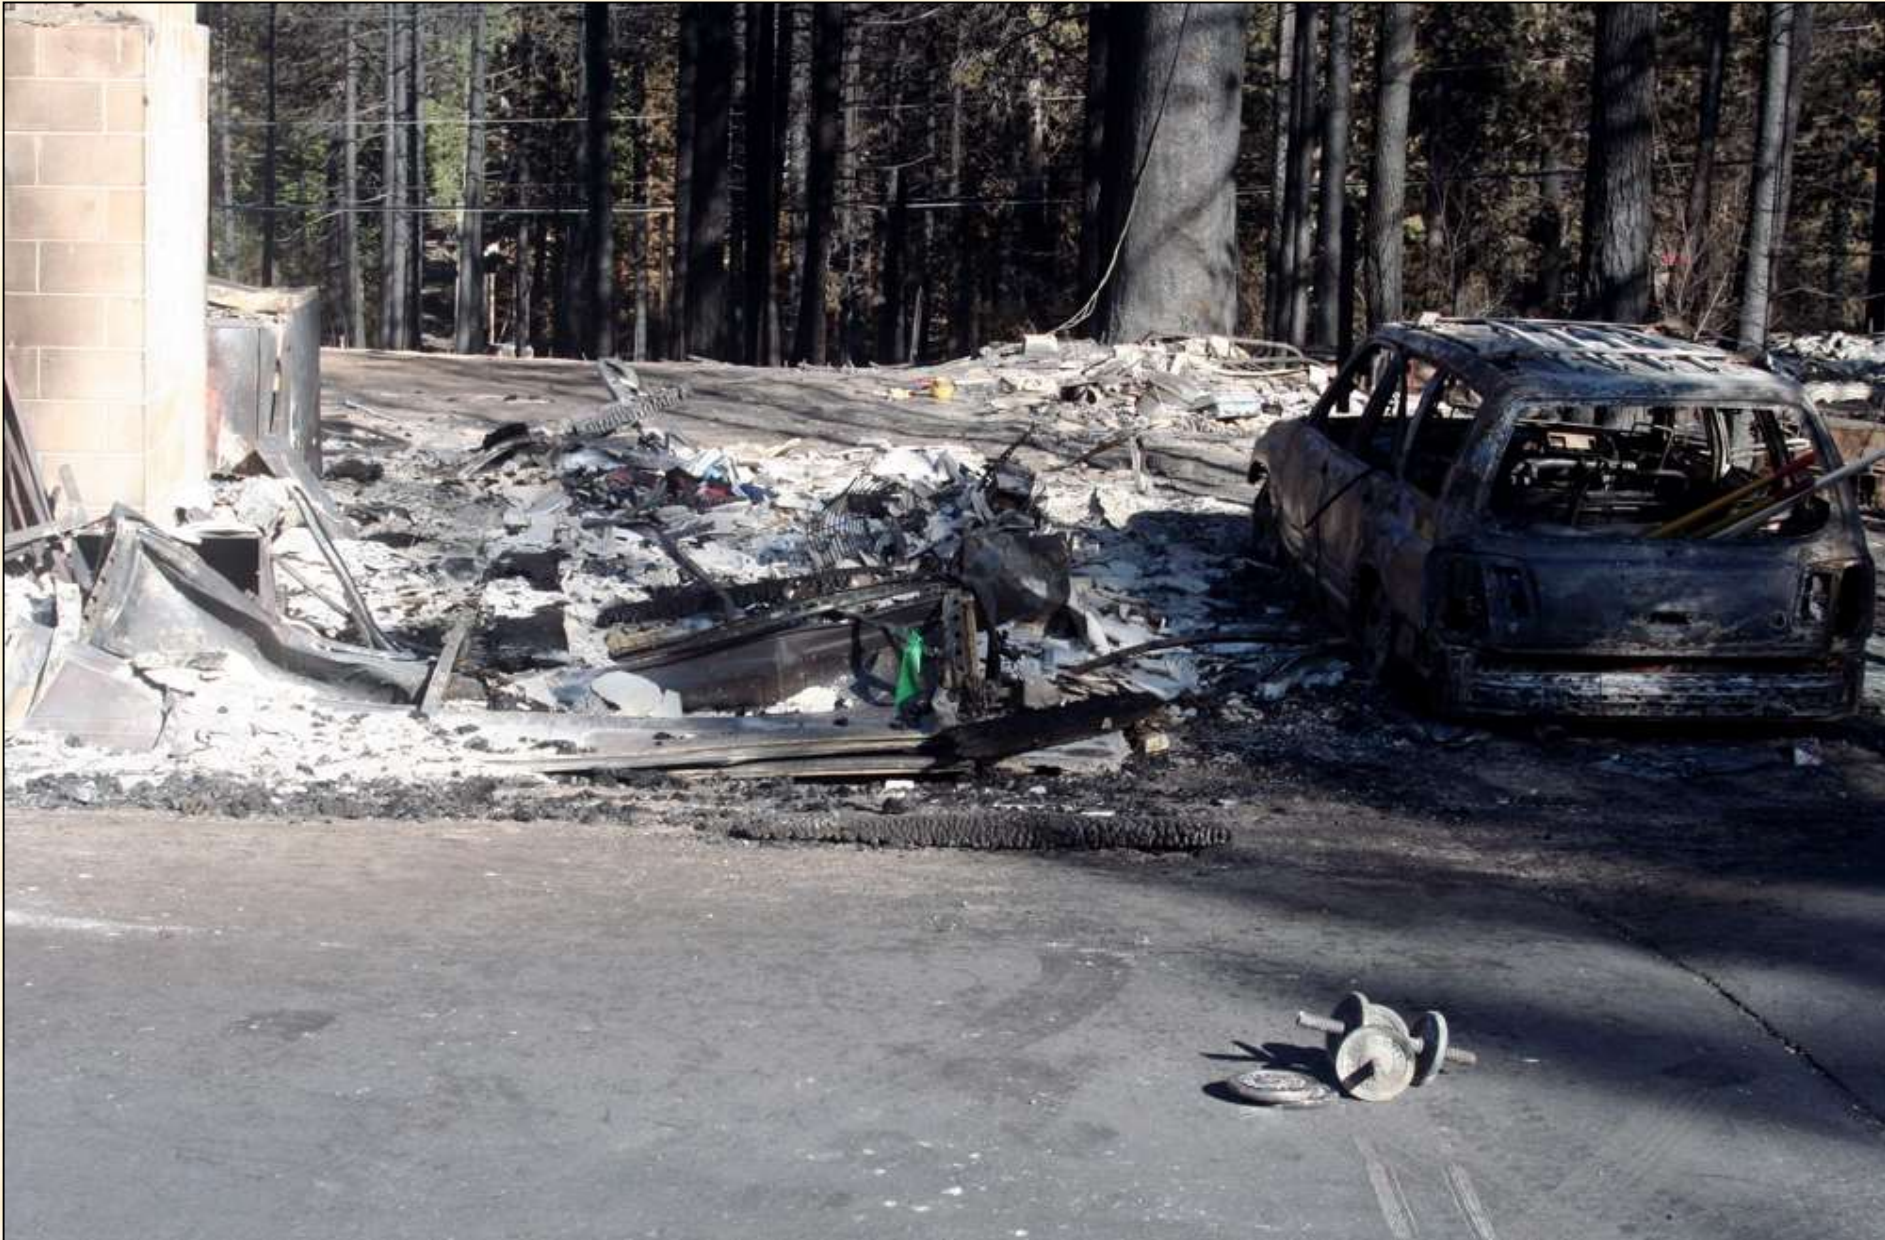
Large urban burned area, with over 300 structures lost

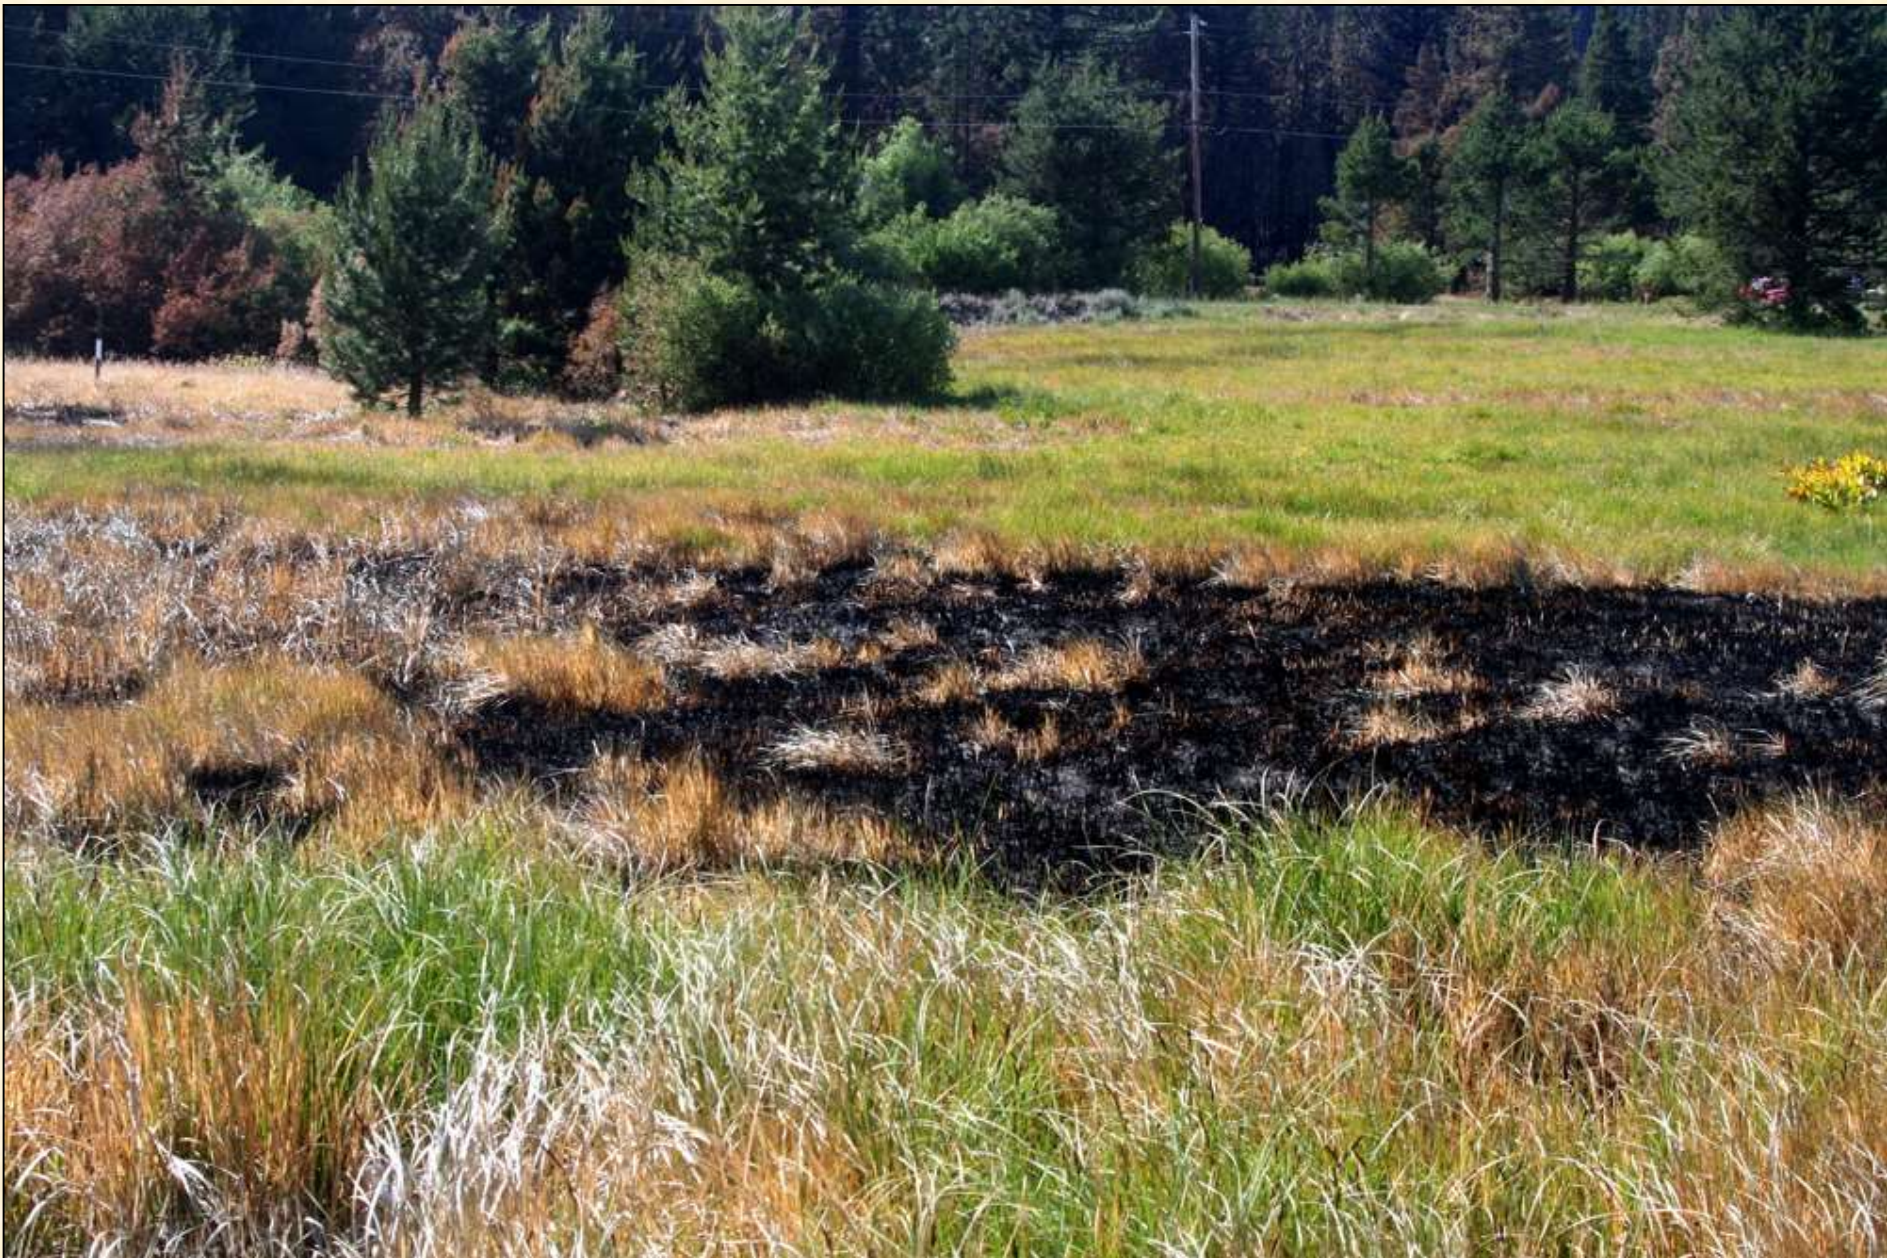
Urban Runoff then Passes through Angora Meadow

- No evidence of massive sediment or nutrient inputs from the burned urban area into Angora Creek.
- However, urban runoff contributed to higher concentrations in the lower Angora Creek site, compared to the upper Angora Creek site.
- Wet meadow restoration areas provided stormwater treatment to runoff from the surrounding catchment.
- Angora urban runoff and Angora Creek conditions after the fire were generally much better than has been observed at other urban sites around the Tahoe Basin.
- However, Angora loading is different from observations after the Gondola Fire; likely due to post-fire storm conditions.

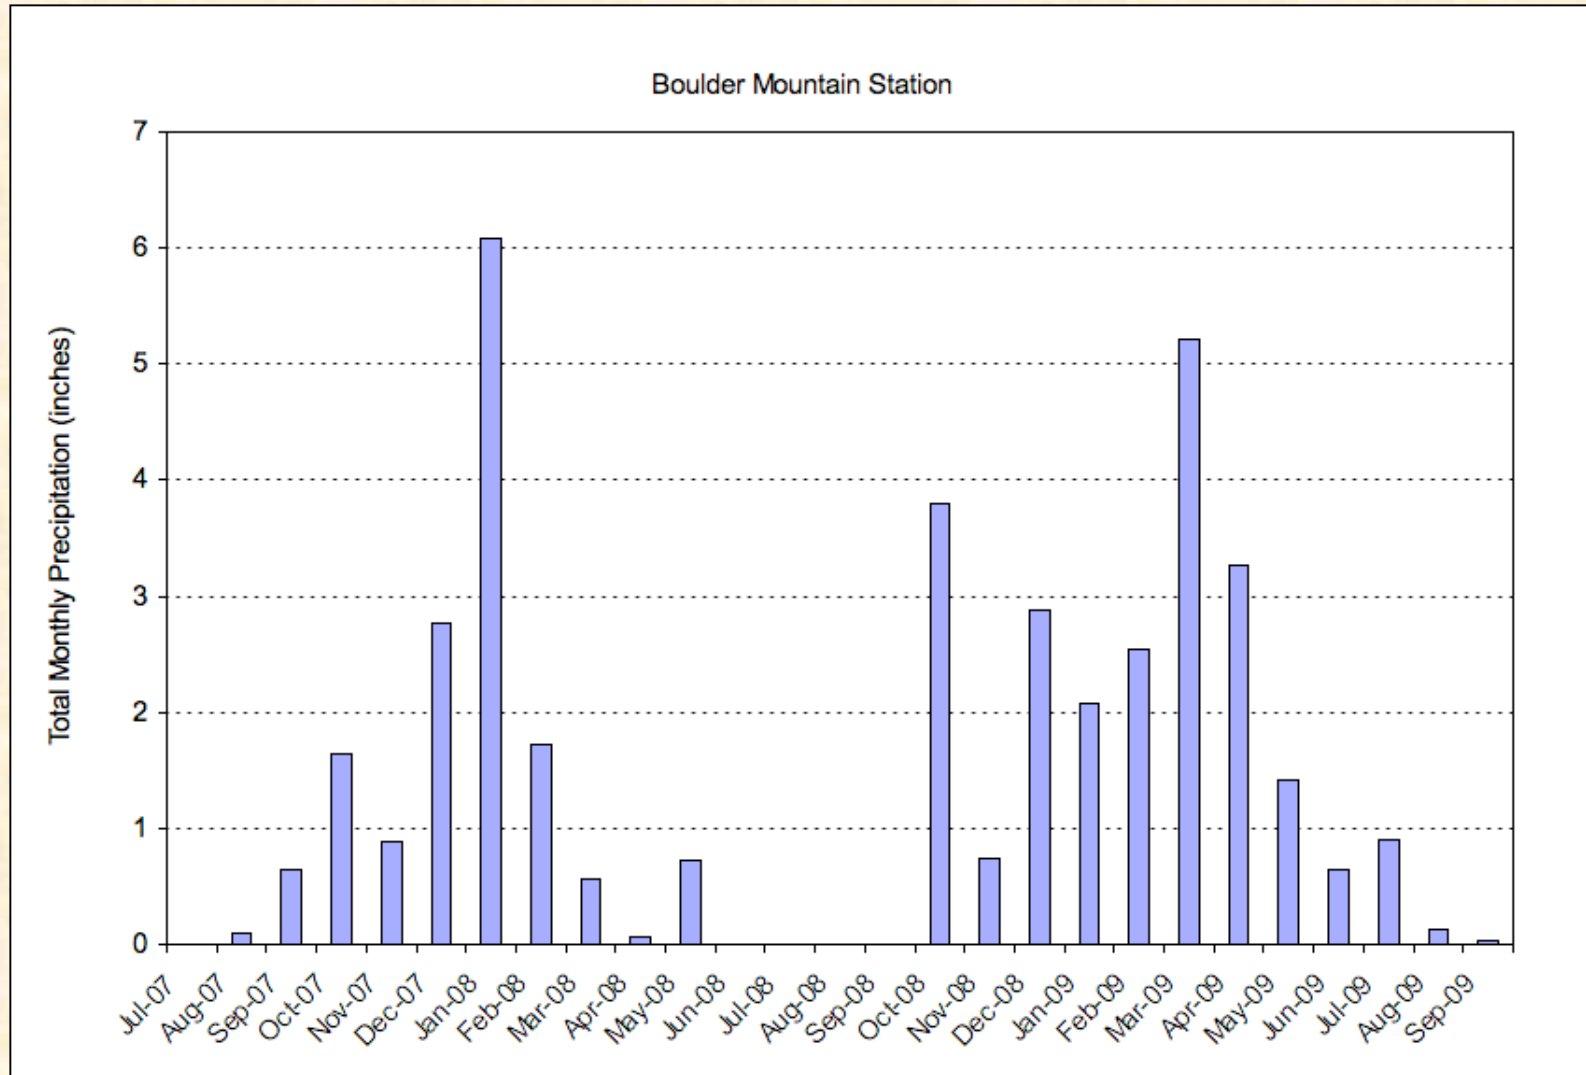
Angora Area Monthly Precipitation

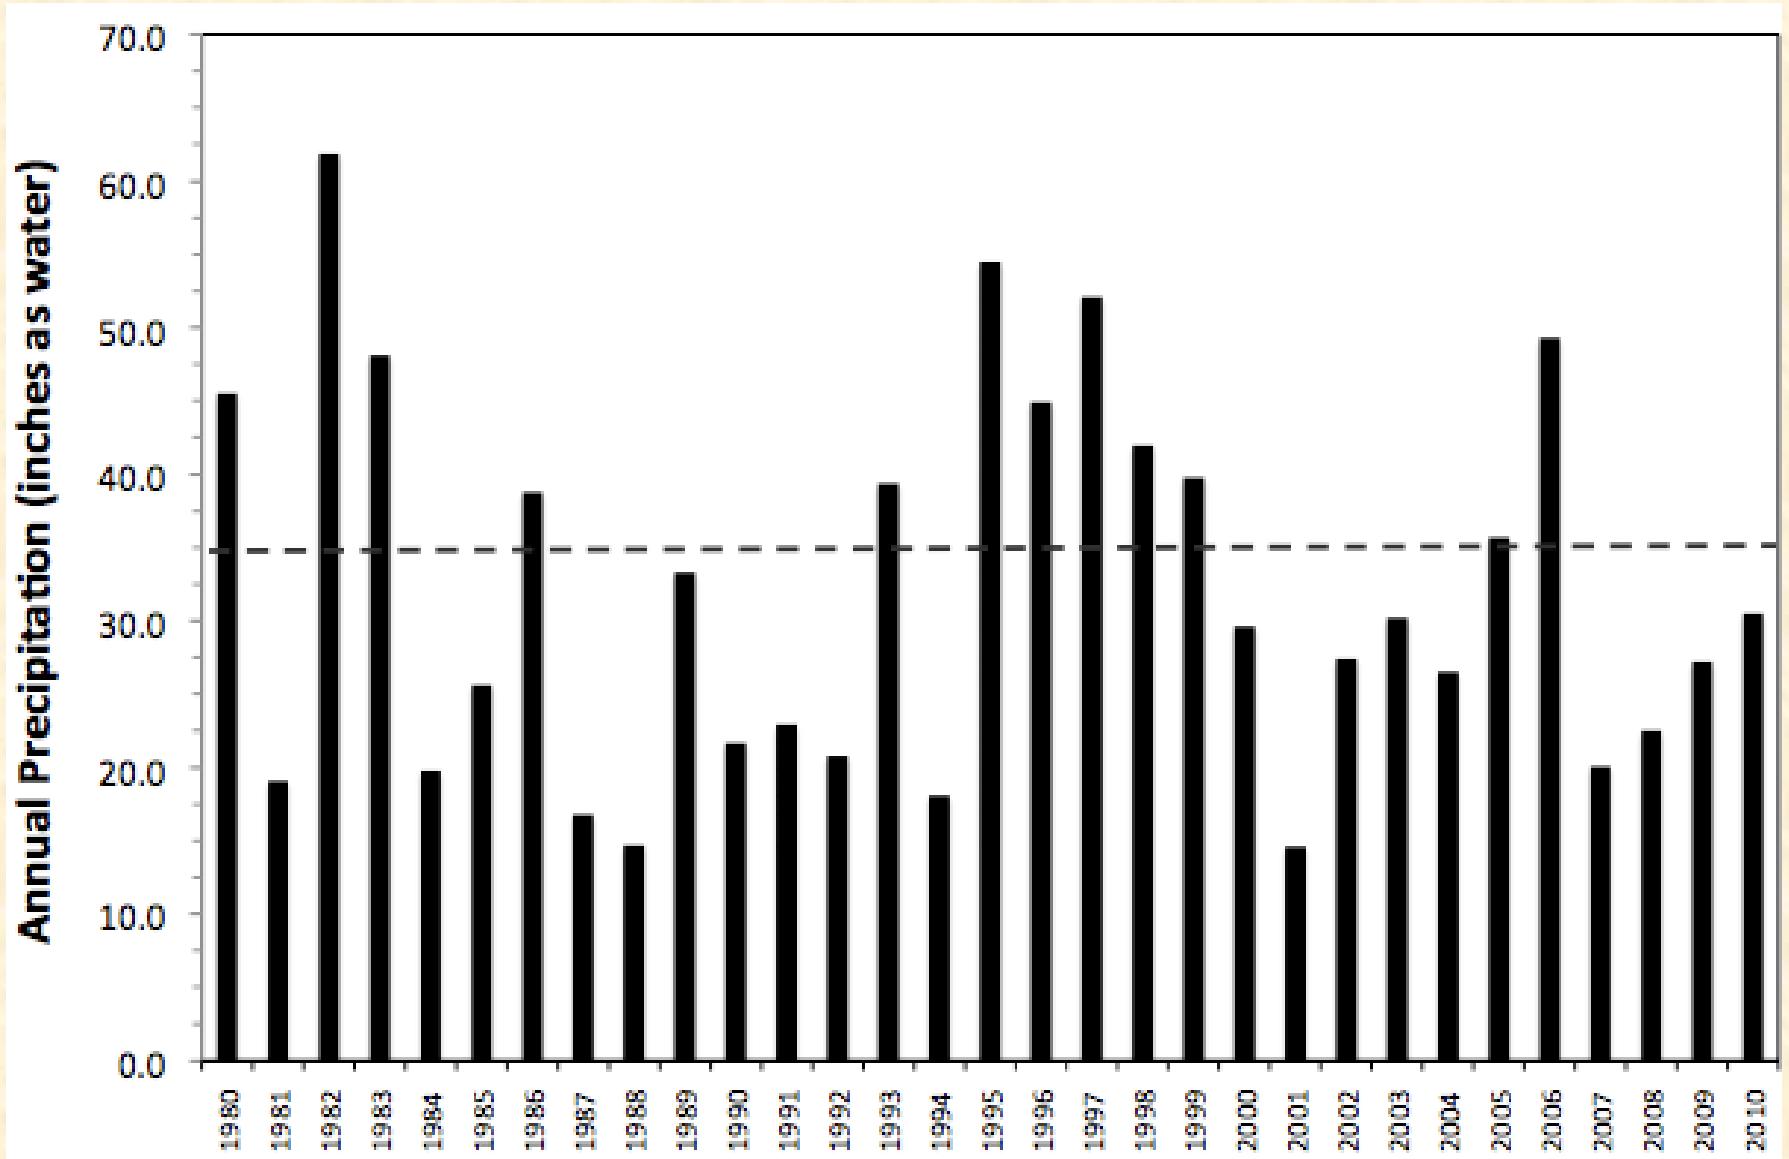
Annual Precipitation Totals at Nearby Fallen Leaf Lake

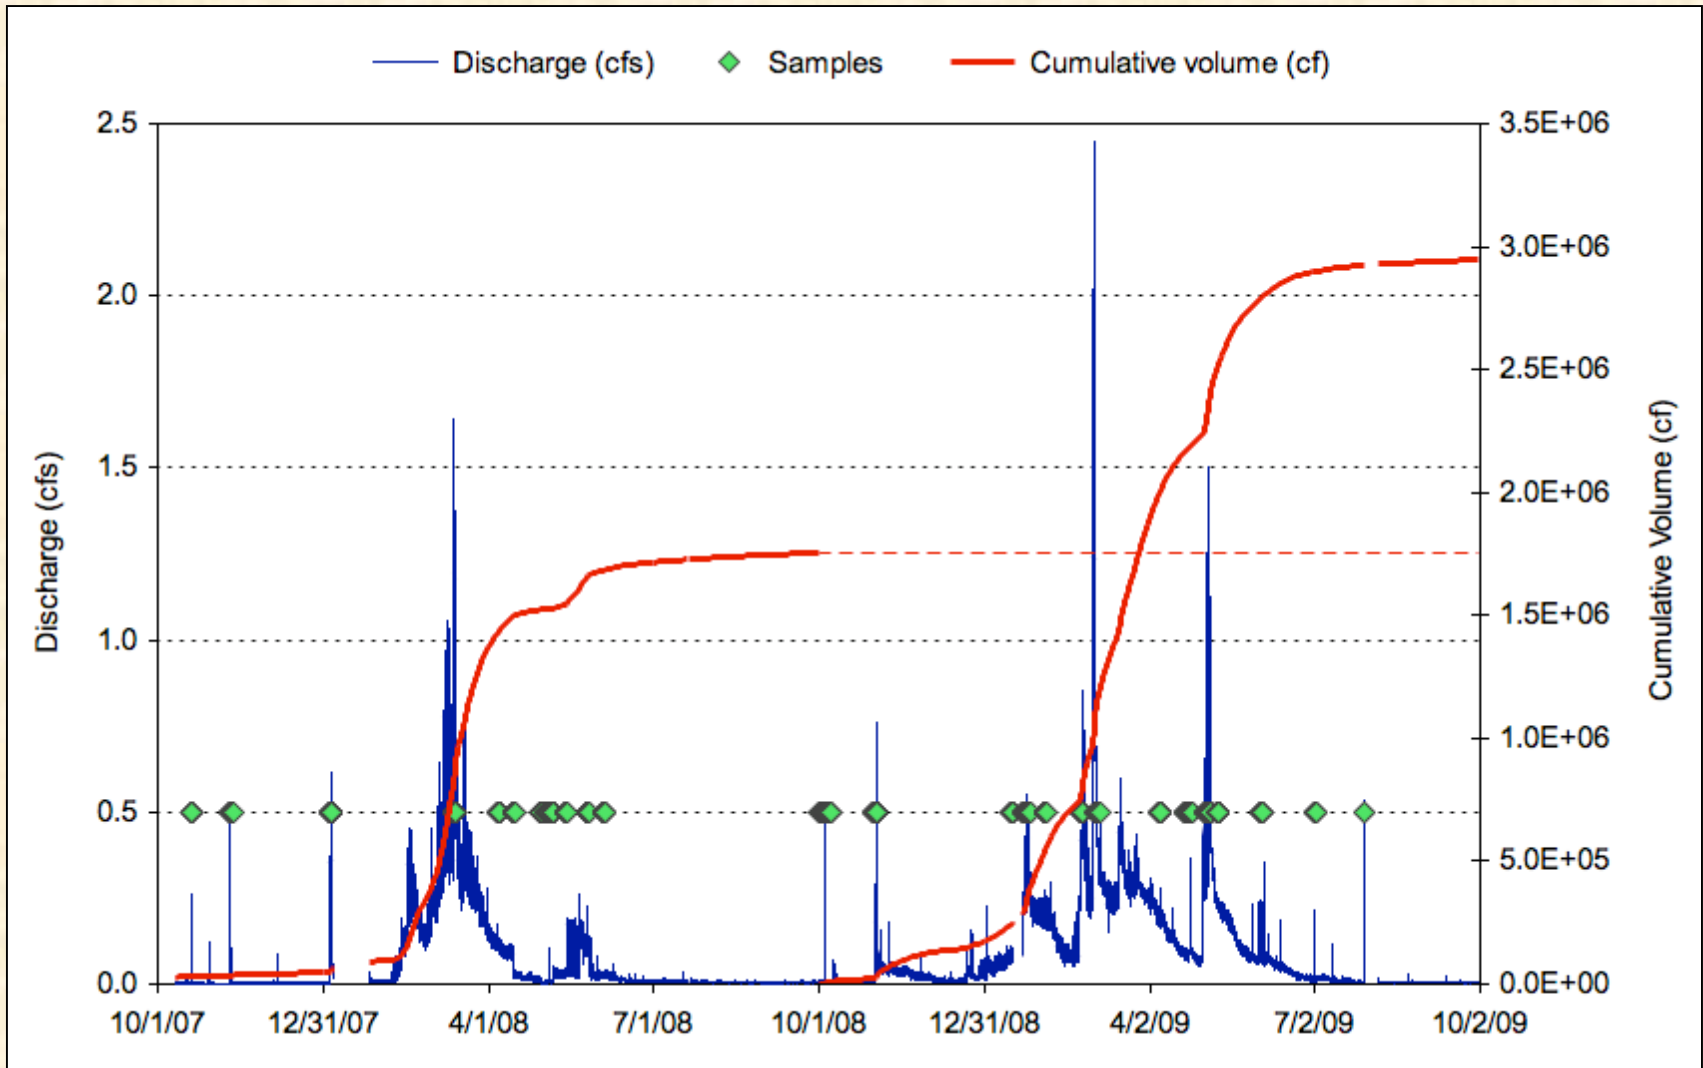
Angora Urban (AE) Sampling, WY2008 thru WY2009

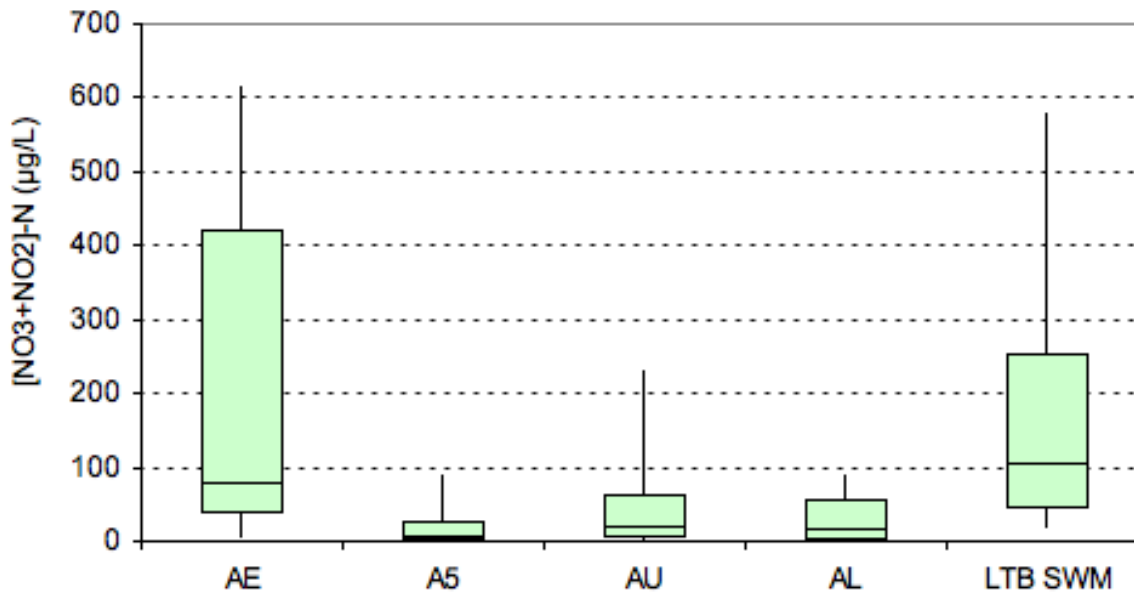
Angora versus Tahoe Basin Stormwater EMCs

TKN & NO₃-N

WY2003 thru
WY2009

Boxes show medians
and quartiles,

whiskers show 10th
and 90th percentiles.

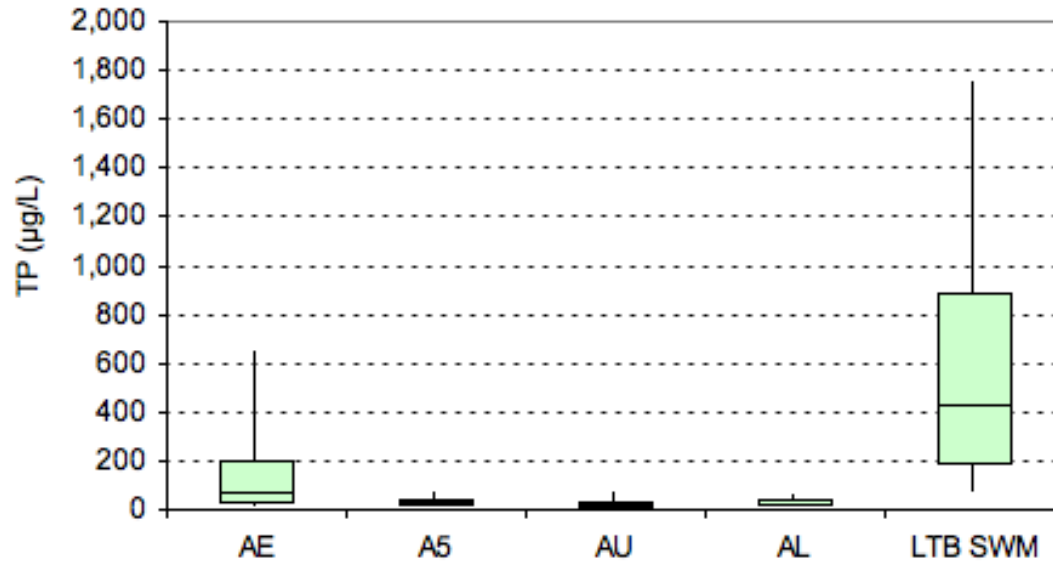
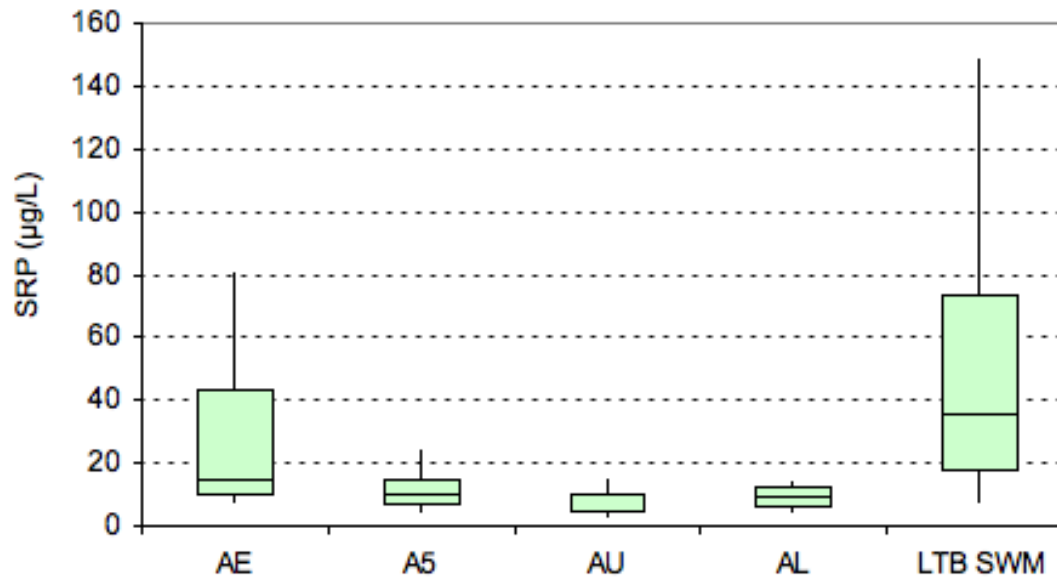
Angora versus Tahoe Basin Stormwater EMCs

TP & SRP

WY2003 thru
WY2009

Boxes show medians
and quartiles,

whiskers show 10th
and 90th percentiles.

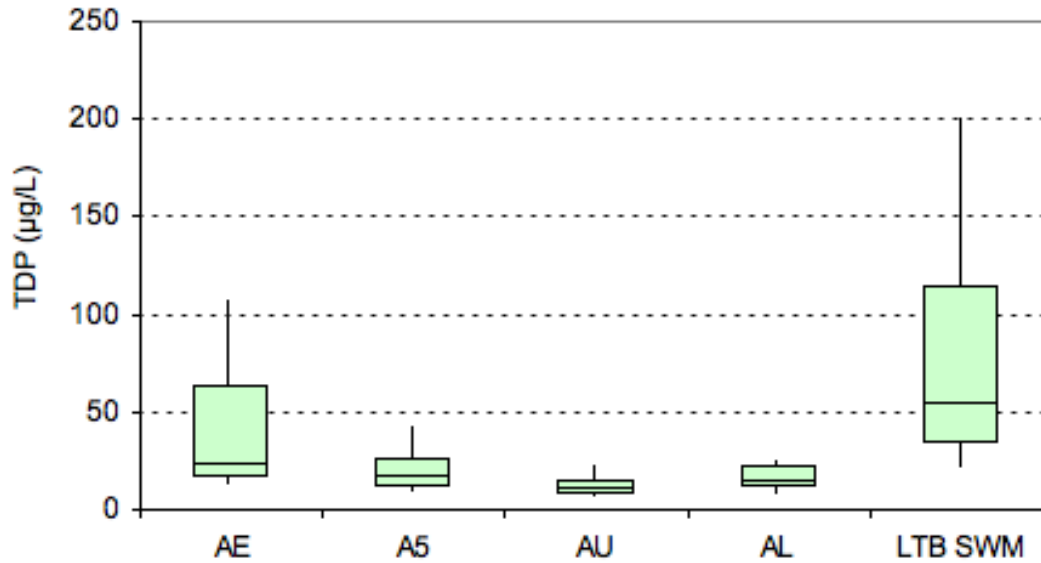
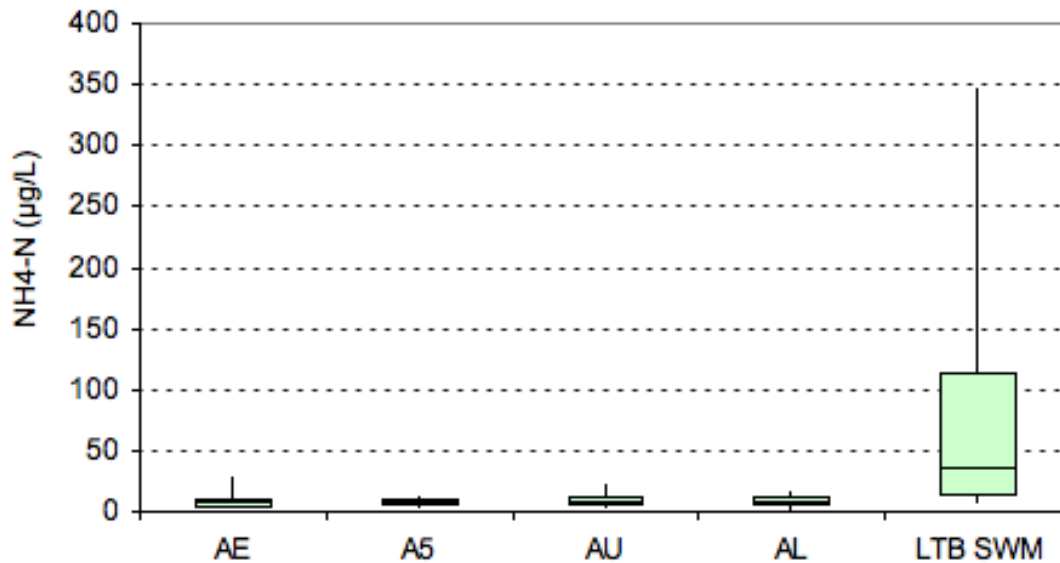
Angora versus Tahoe Basin Stormwater EMCs

TDP & NH₄-N

WY2003 thru
WY2009

Boxes show medians
and quartiles,

whiskers show 10th
and 90th percentiles.

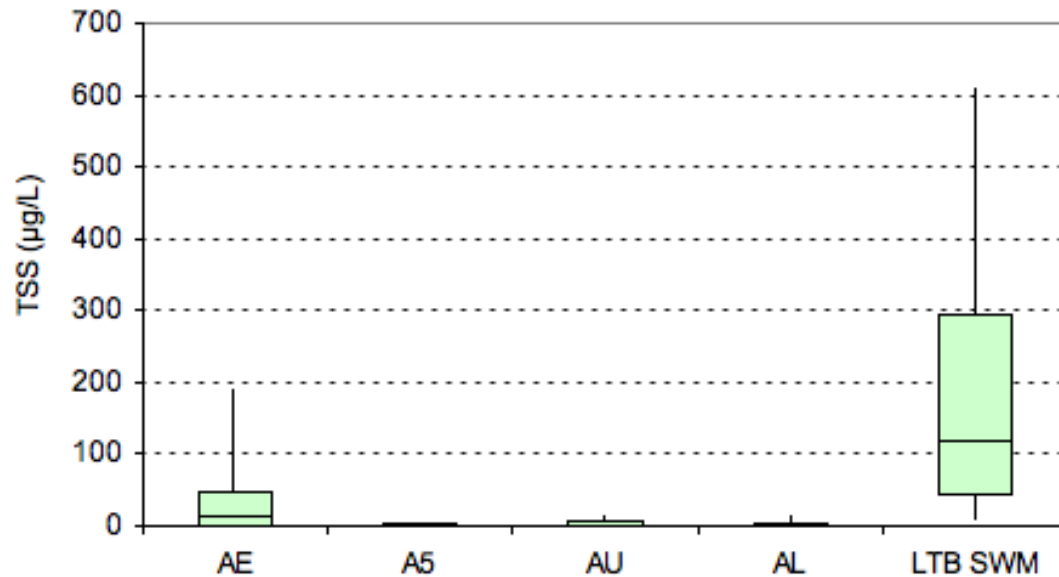
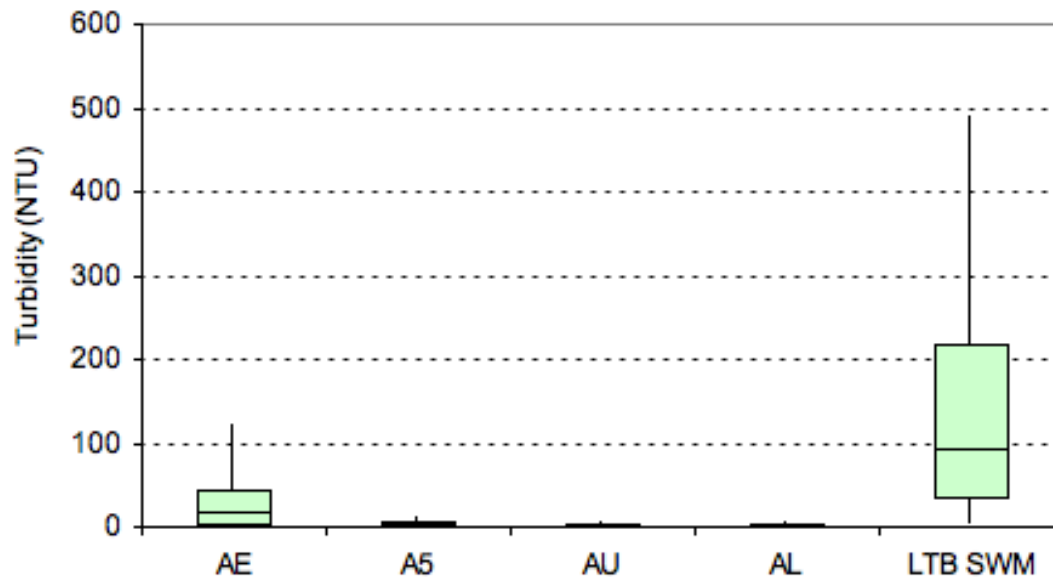
Angora versus Tahoe Basin Stormwater EMCs

TSS & Turbidity

WY2003 thru
WY2009

Boxes show medians
and quartiles,

whiskers show 10th
and 90th percentiles.

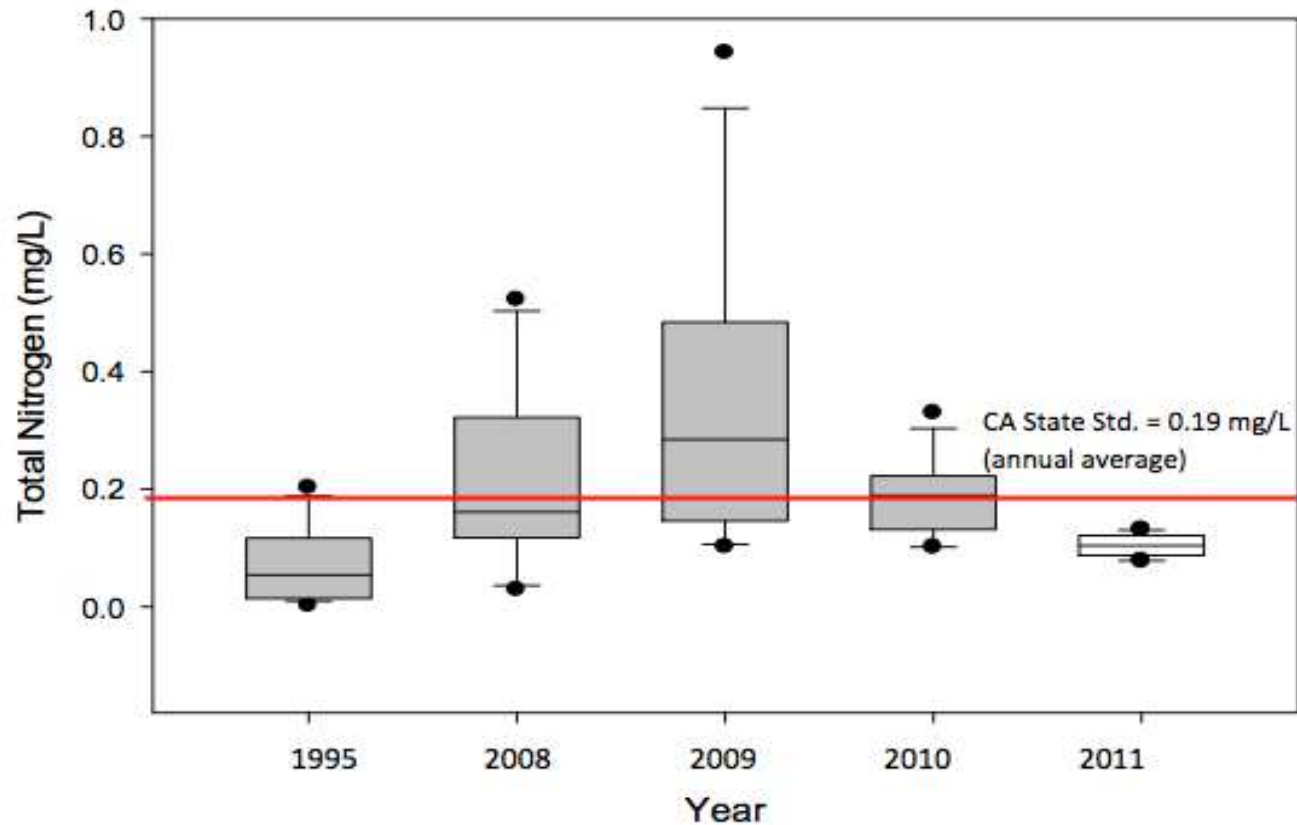
Figure 3. Total Nitrogen During Spring Runoff (February - July)
Post-fire Years (2008-2011) and 1995 (reference)

Boxplot footnote: The black horizontal line across the box represents the median value of the data set. The top and bottom of each box represents the 75th and 25th percentiles respectively, and the horizontal line at the top and bottom of the vertical line represent the 90th and 10th percentiles respectively.

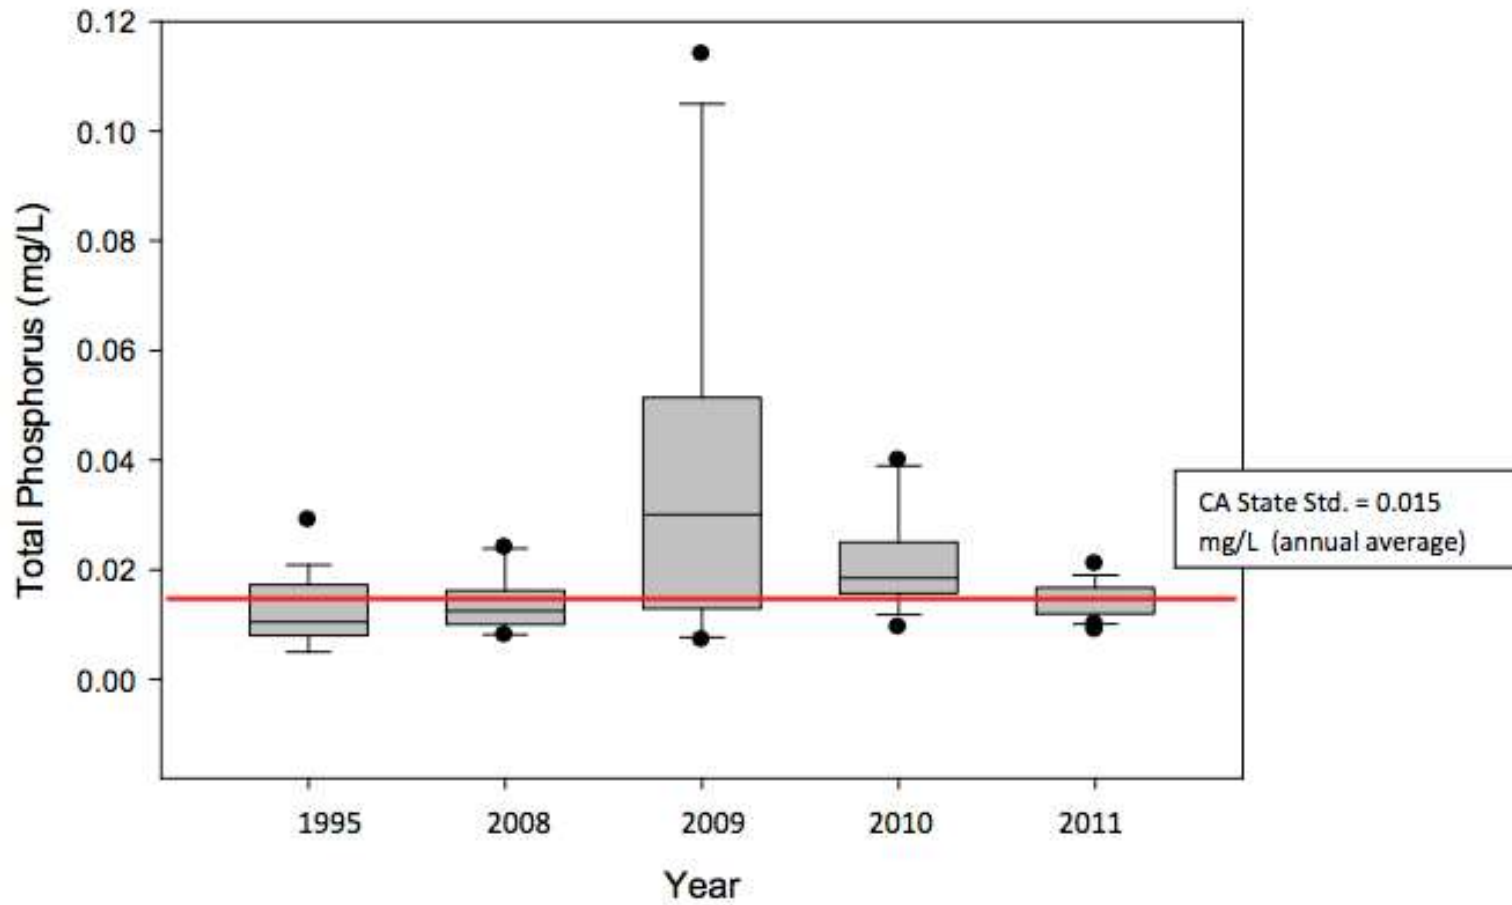
Figure 4. Total Phosphorus During Spring Runoff (February - July)
Post-fire Years (2008-2011) and 1995 (reference)

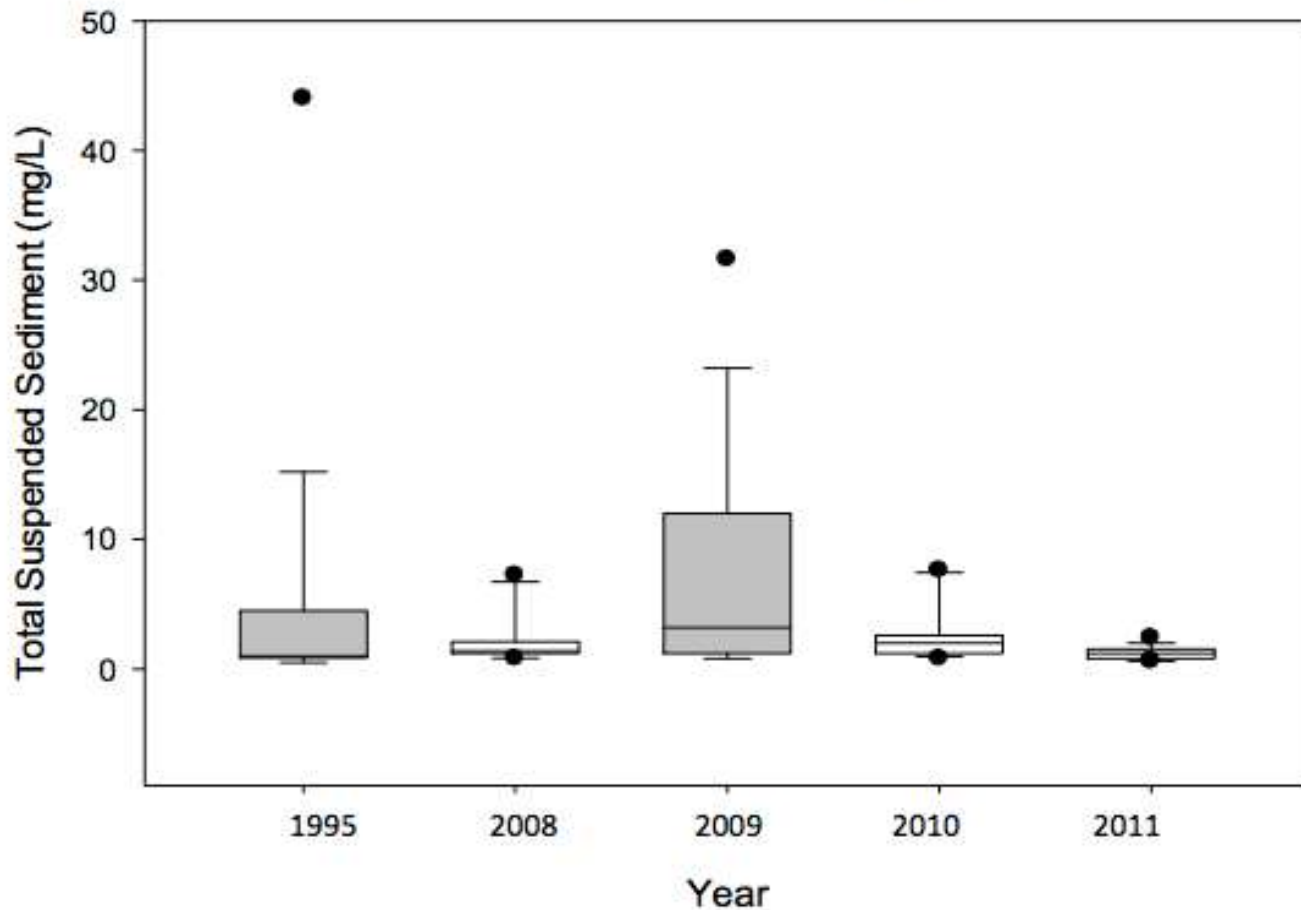
Figure 5: Total Suspended Sediment During Spring Runoff (February - July)
Post-fire Years (2008-2011) and 1995 (reference)
(CA State Std. = 60 mg/L)

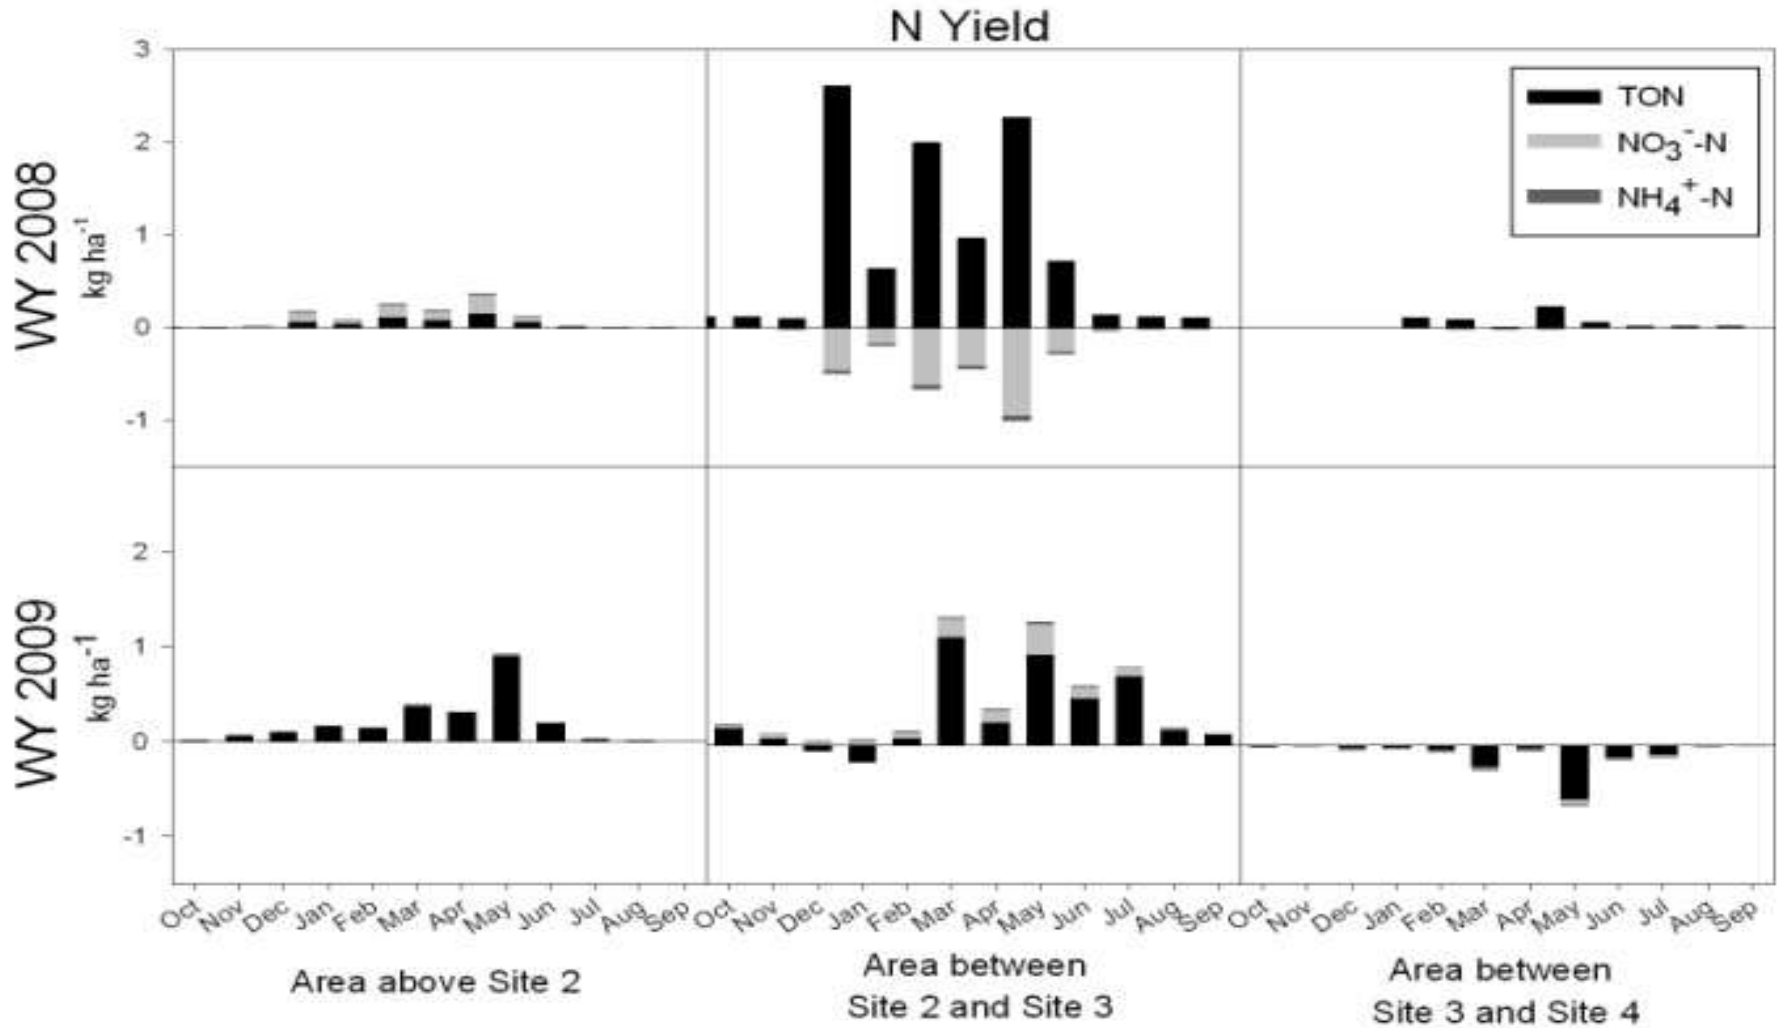
Angora Creek Nitrogen Yields (kg/ha/mo)

Note: positive values indicate contribution, negative values indicate retention.
