Water Quality Response to the Angora Fire, Lake Tahoe, CA

Angora Fire Science Symposium

June 23, 2017

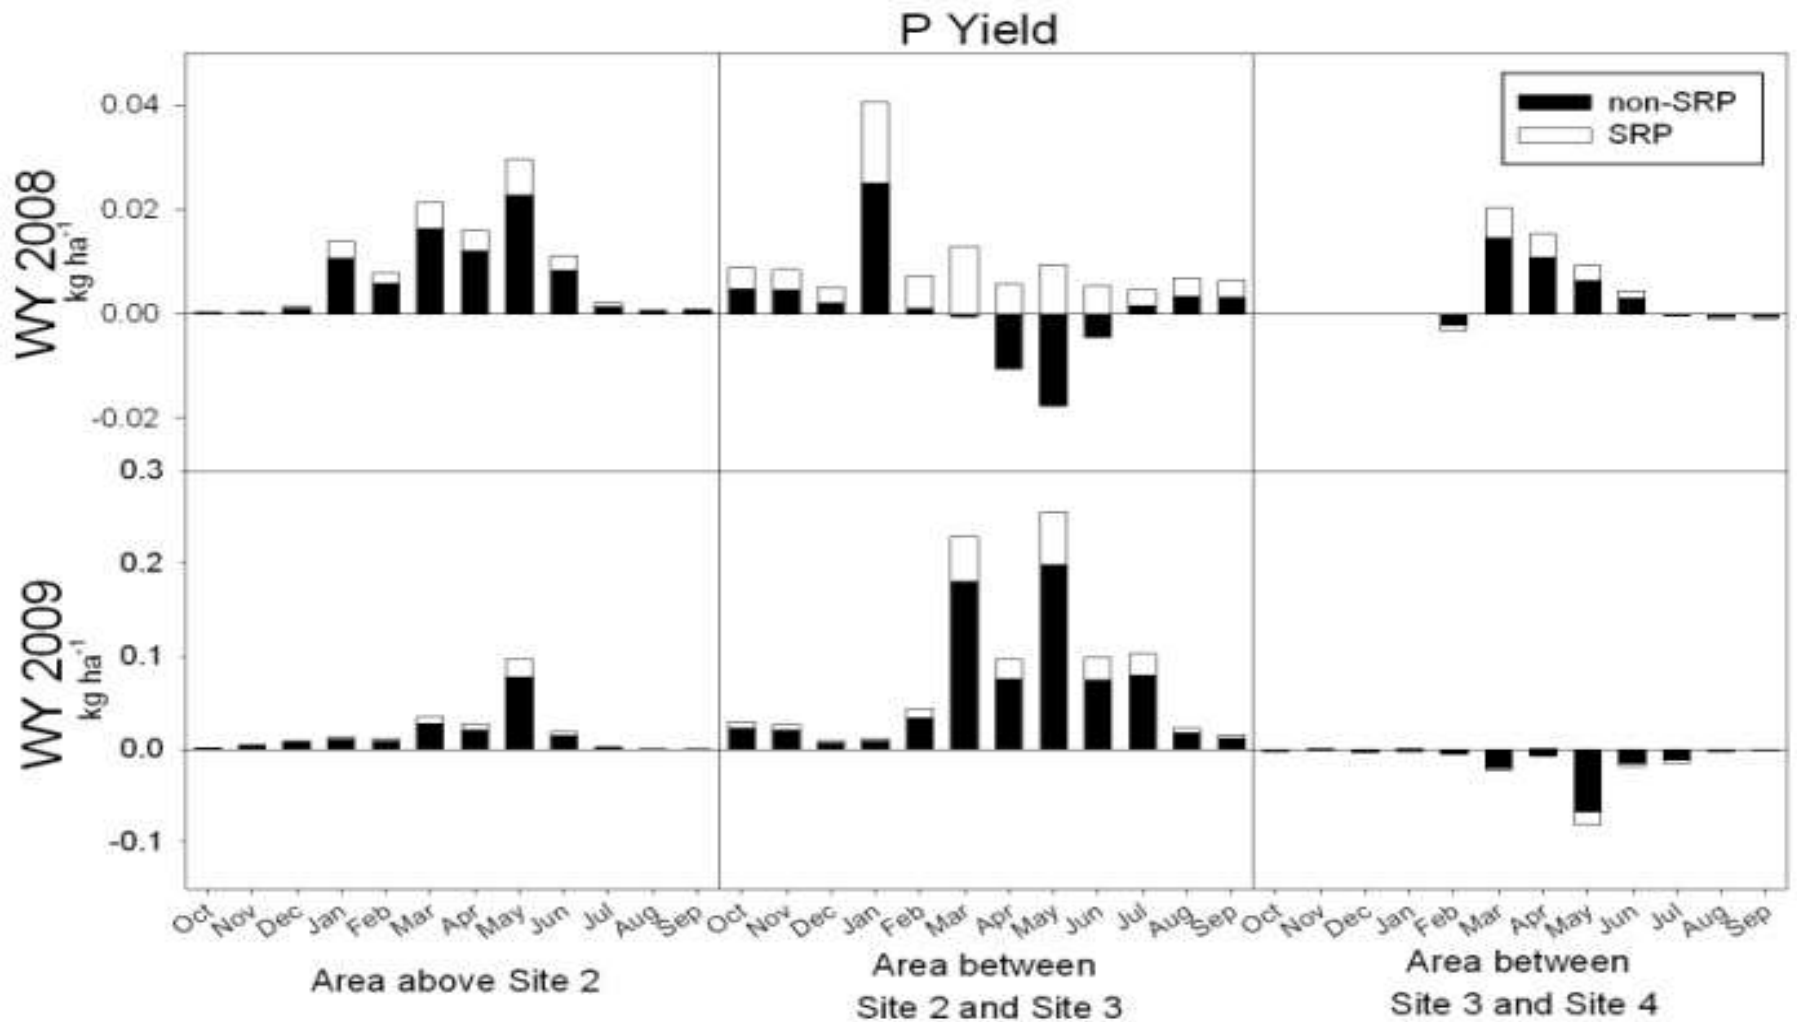
Angora Creek Phosphorus Yields (kg/ha/mo)

Note: positive values indicate contribution, negative values indicate retention.

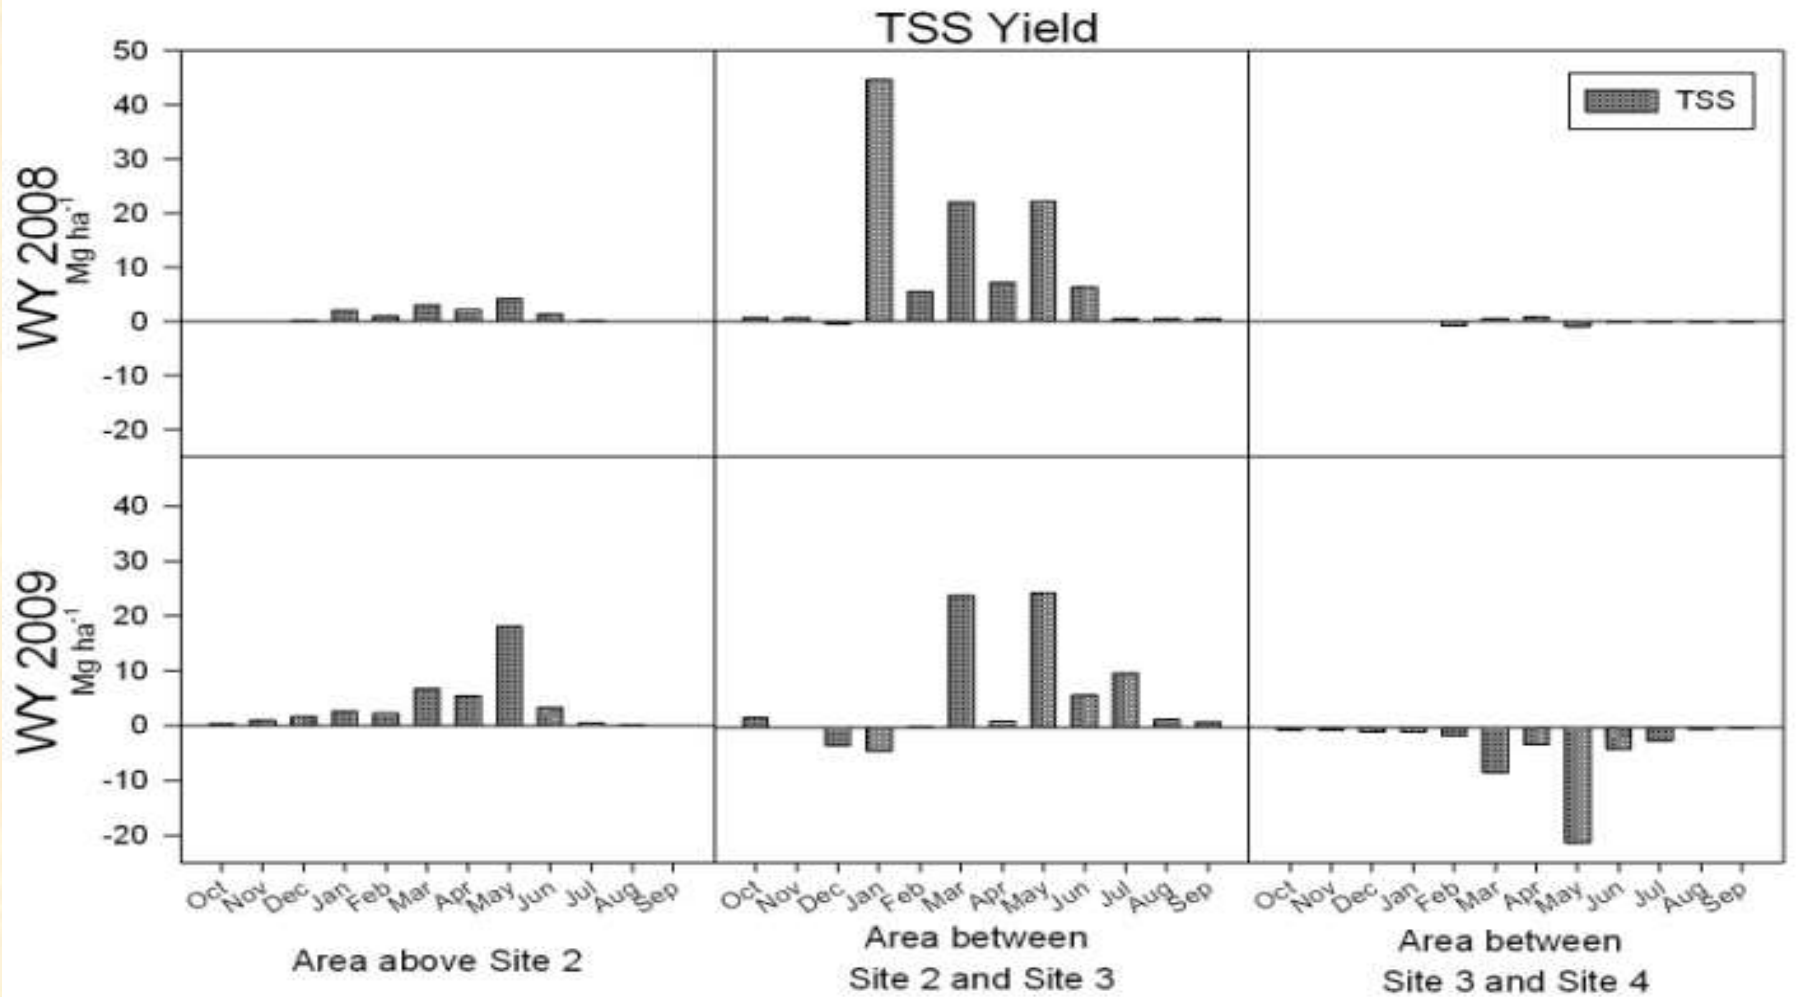
Angora Creek Sediment Yields (Mg/ha/mo)

Note: positive values indicate contribution, negative values indicate retention.
