Reducing the Vulnerability of the Built Environment

Steve Quarles

UCCE Advisor, Durability of Wood-frame Buildings

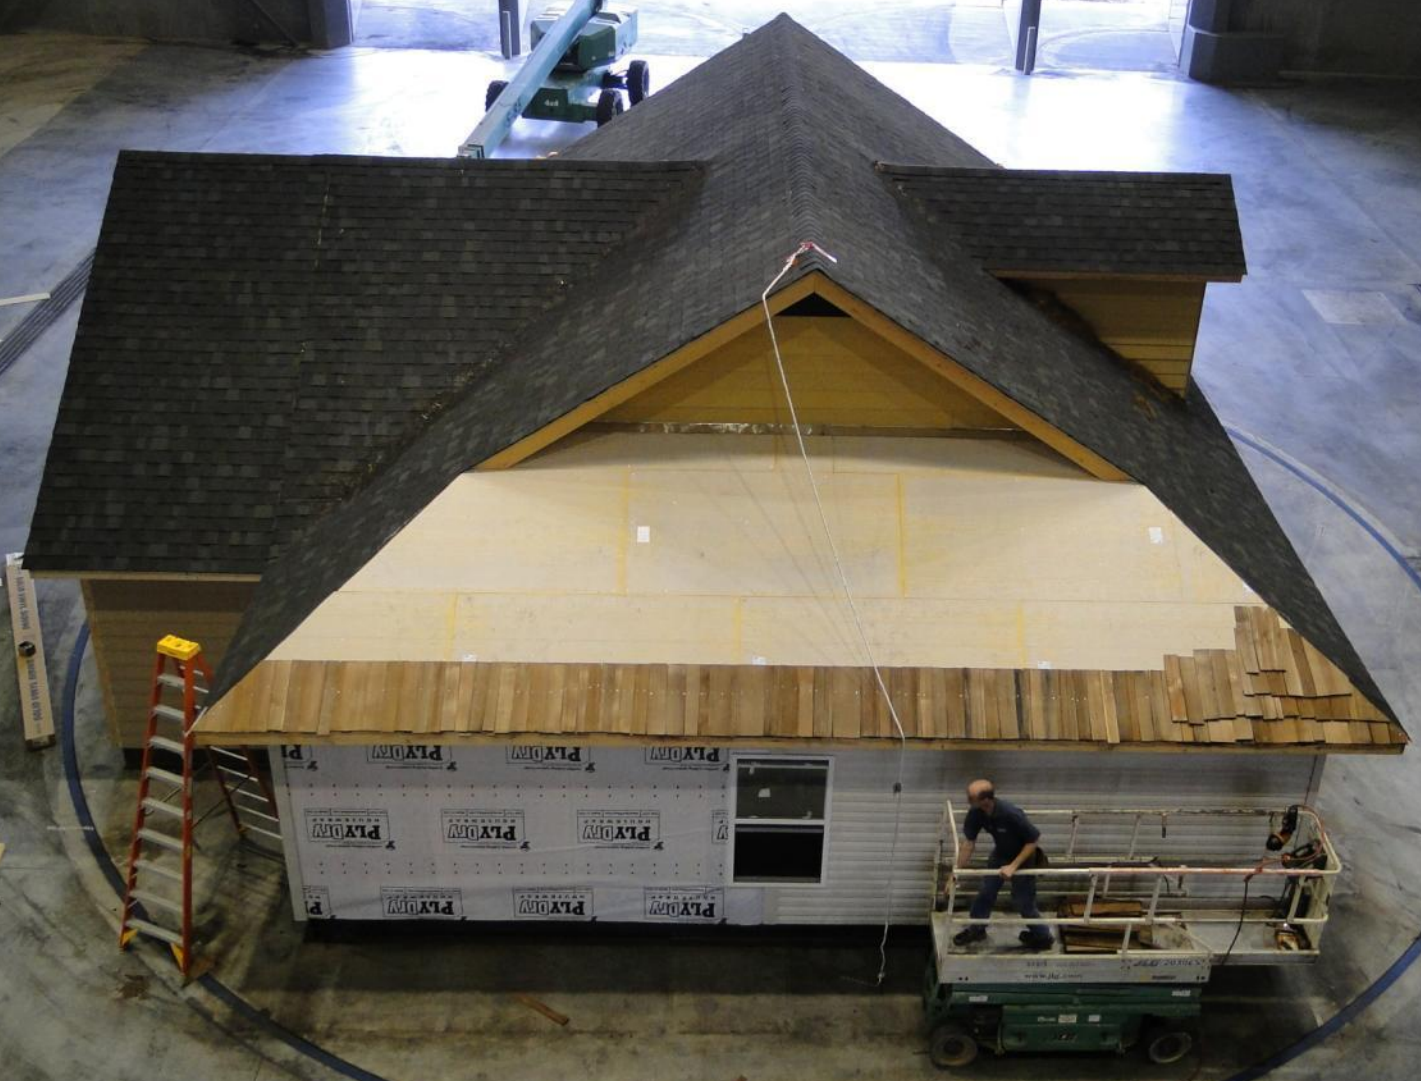
Test Building

Five firebox / ember generators

5 ducts at
upper level

5 ducts at
mid-level

2 ducts at
low level
(end units)

3 ducts at
floor level
(center units)

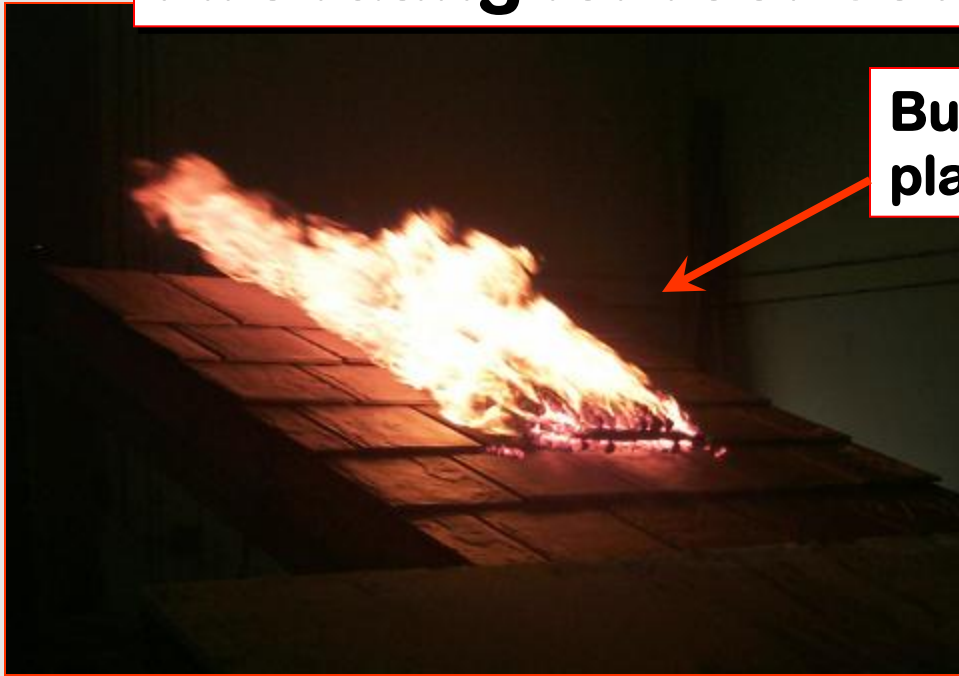
Fire rating for roof coverings

Burning [12"x 12"] 'A Brand' placed on roof covering.

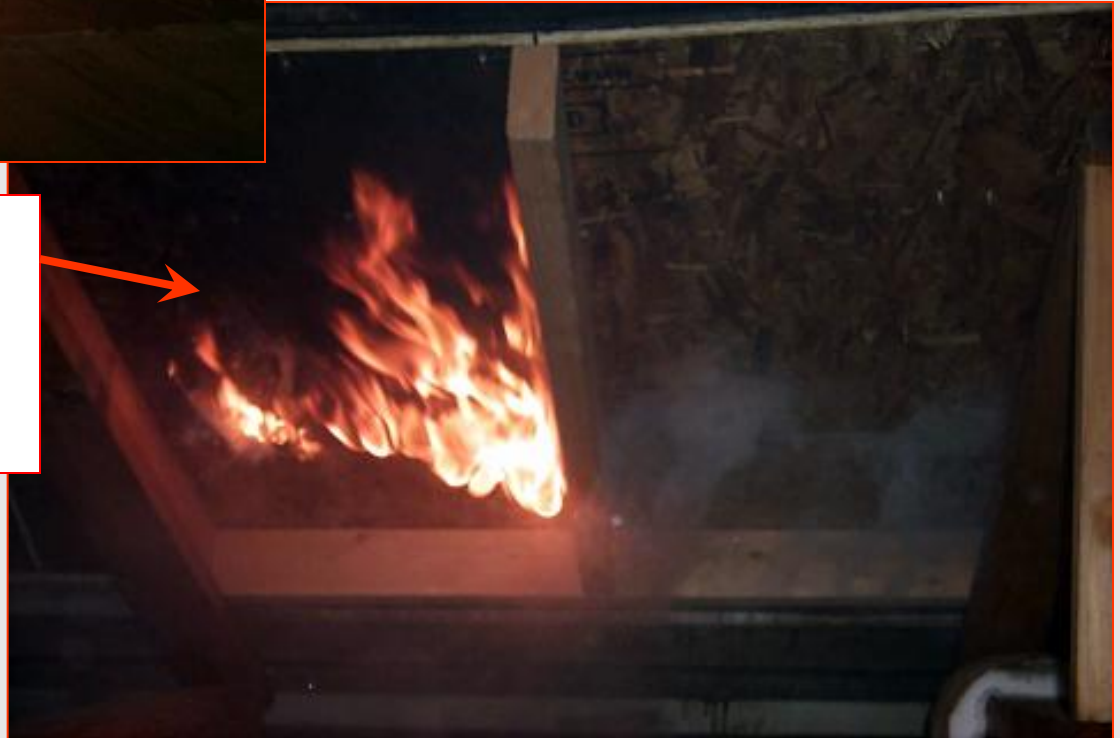
Flame penetrated through to the underside of the roof sheathing, into what would be the attic.

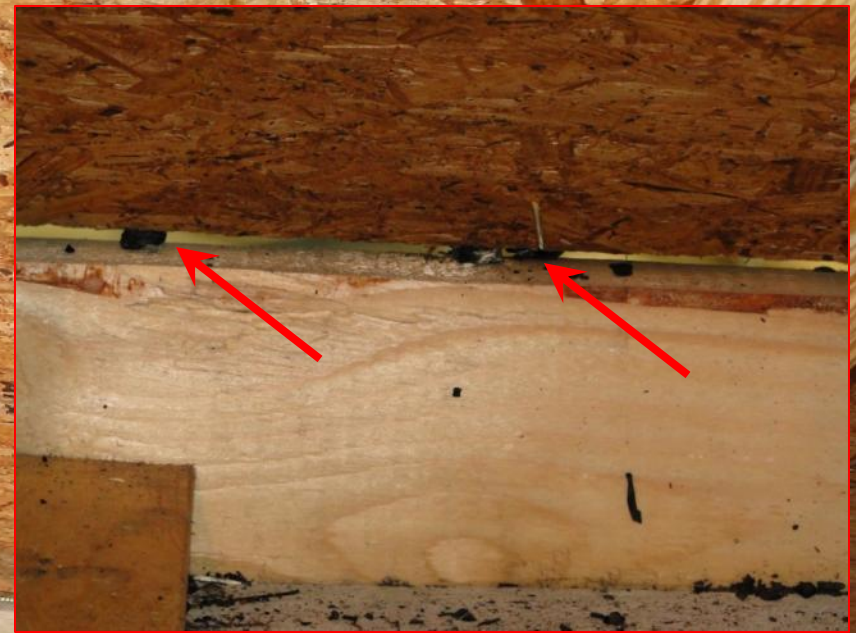
Truss bays, soffited eave - *no* angle flashing at roof edge

Accumulation of embers / firebrands

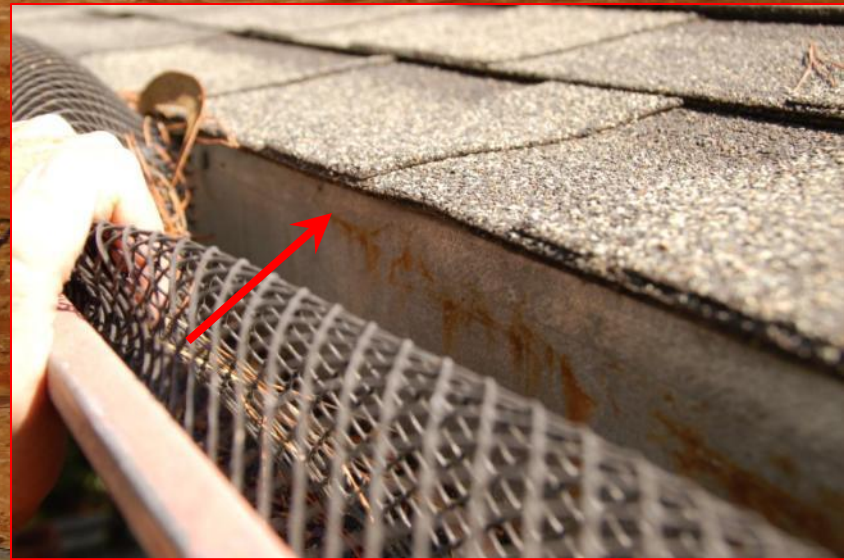
**Truss bay, soffited eave -
angle flashing at roof edge**

Minimal accumulation of embers / firebrands

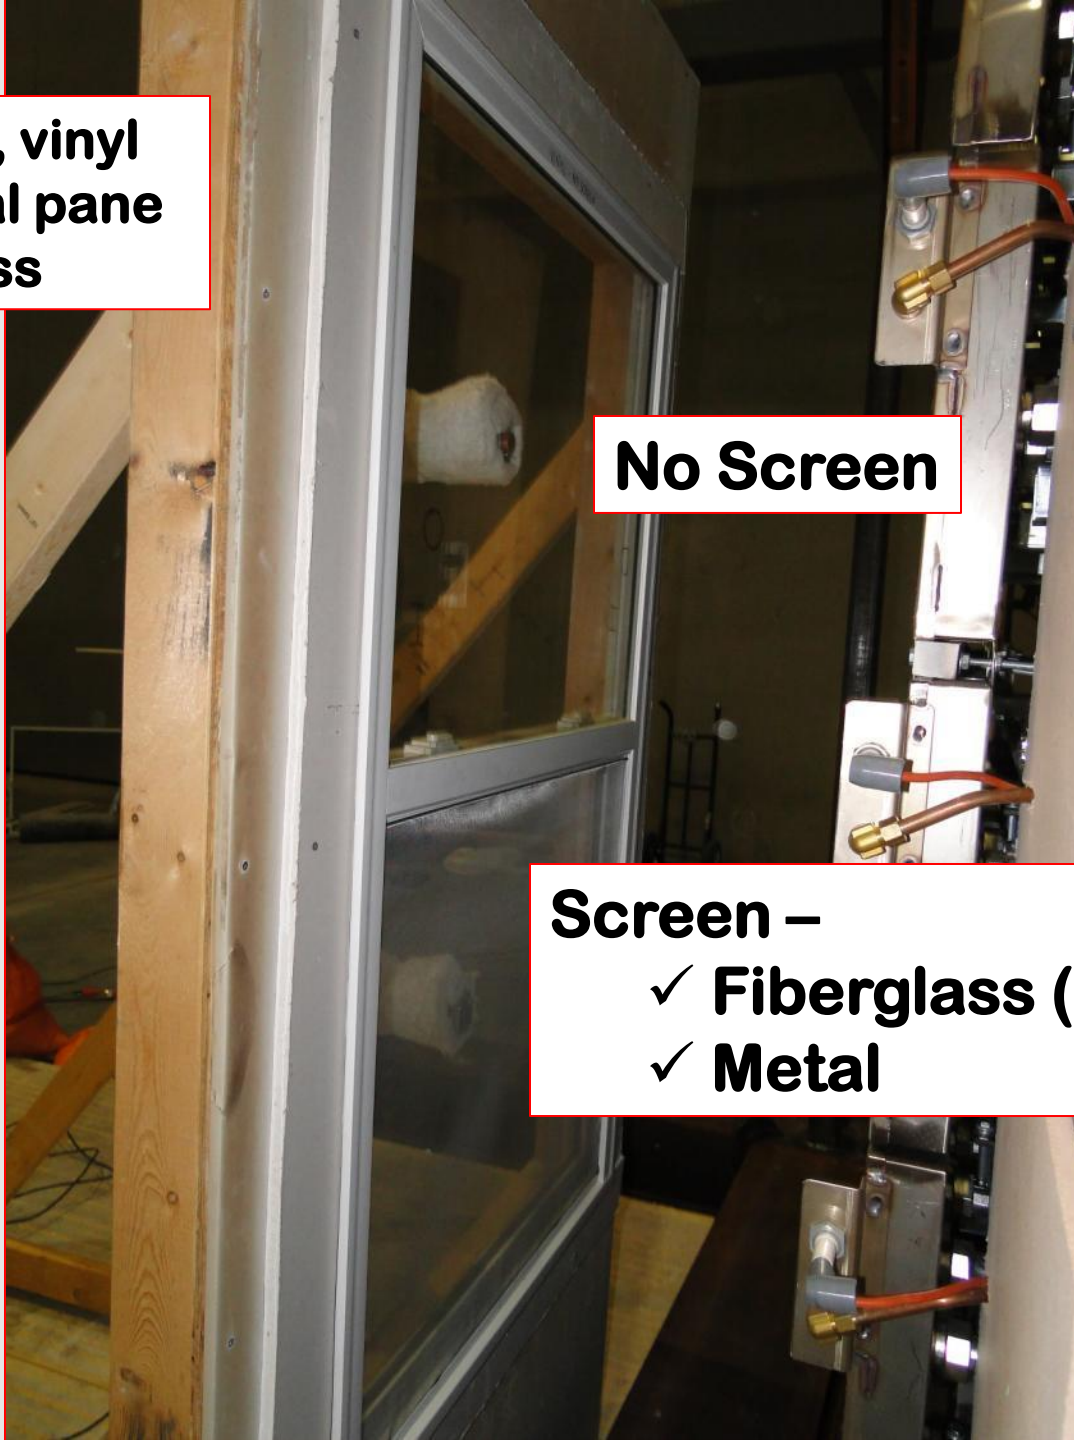
Screen study, vinyl windows, dual pane annealed glass

No Screen

Screen –

- ✓ **Fiberglass (plastic clad)**
- ✓ **Metal**

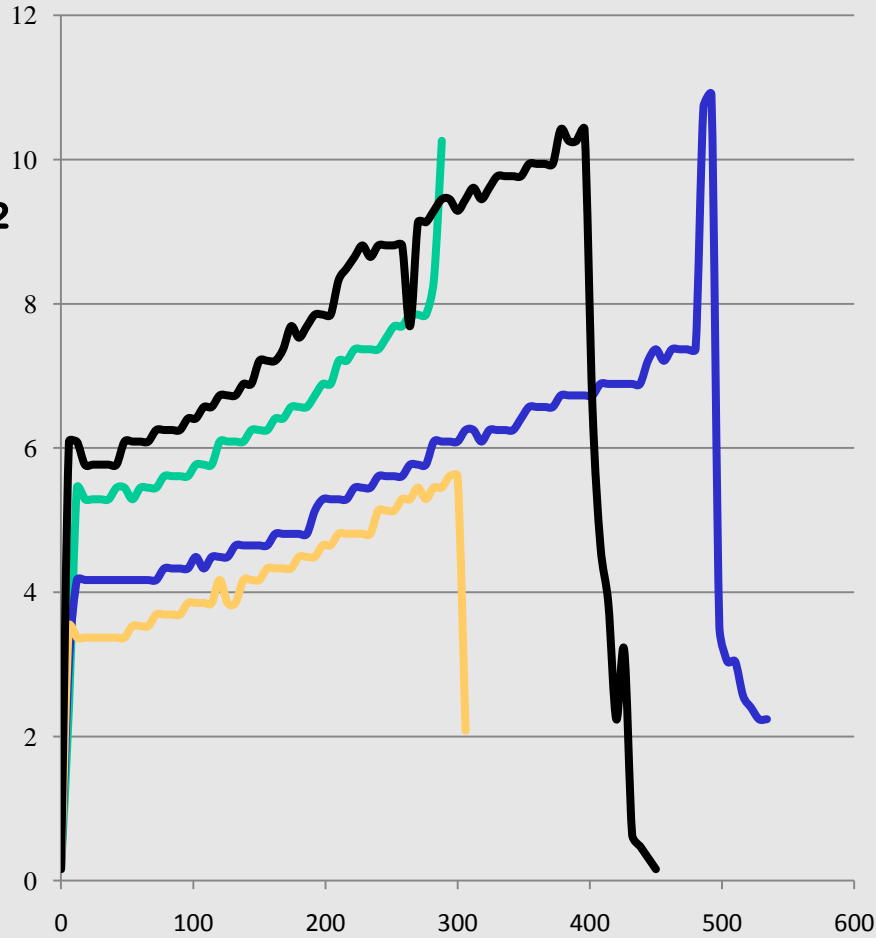
Heat Flux, kW/m²

- No Screen
- Metal Screen
- Fiberglass Screen
- No Screen - Curtain

Time , s

Radiant Exposure: 35 kW/m²

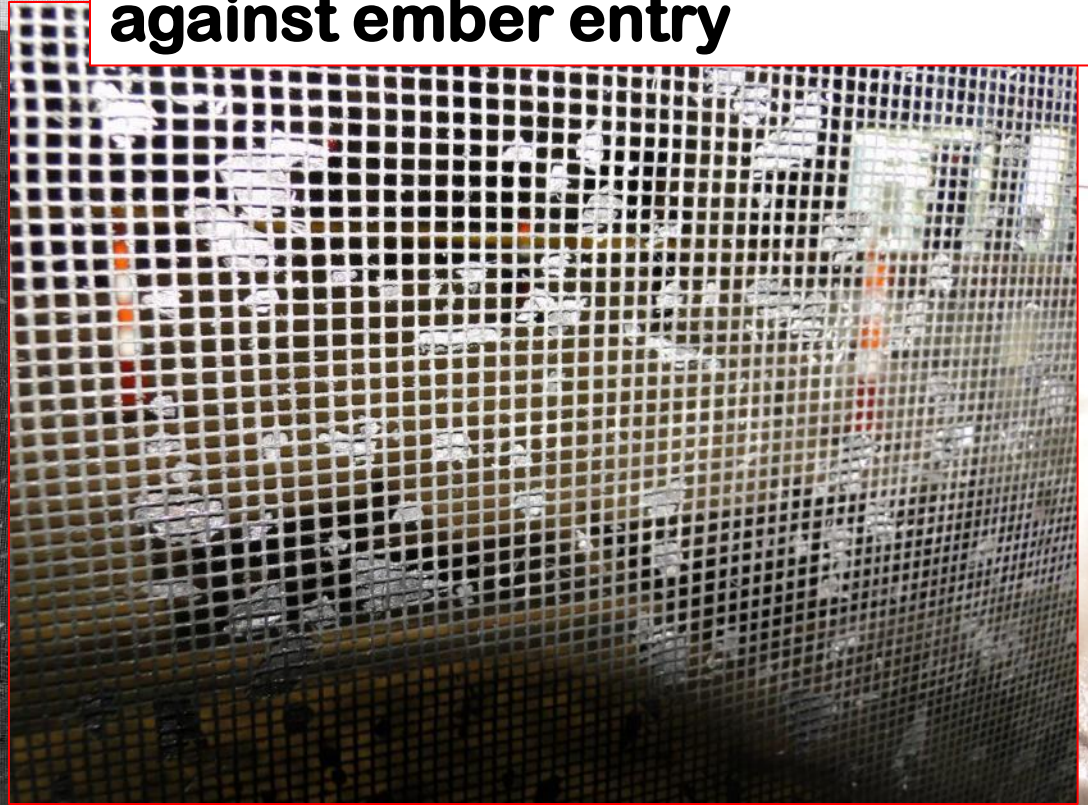
Where screen intact, protects against ember entry

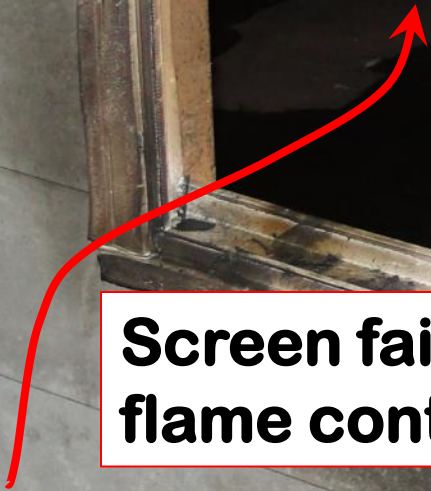
Screen failure after flame contact

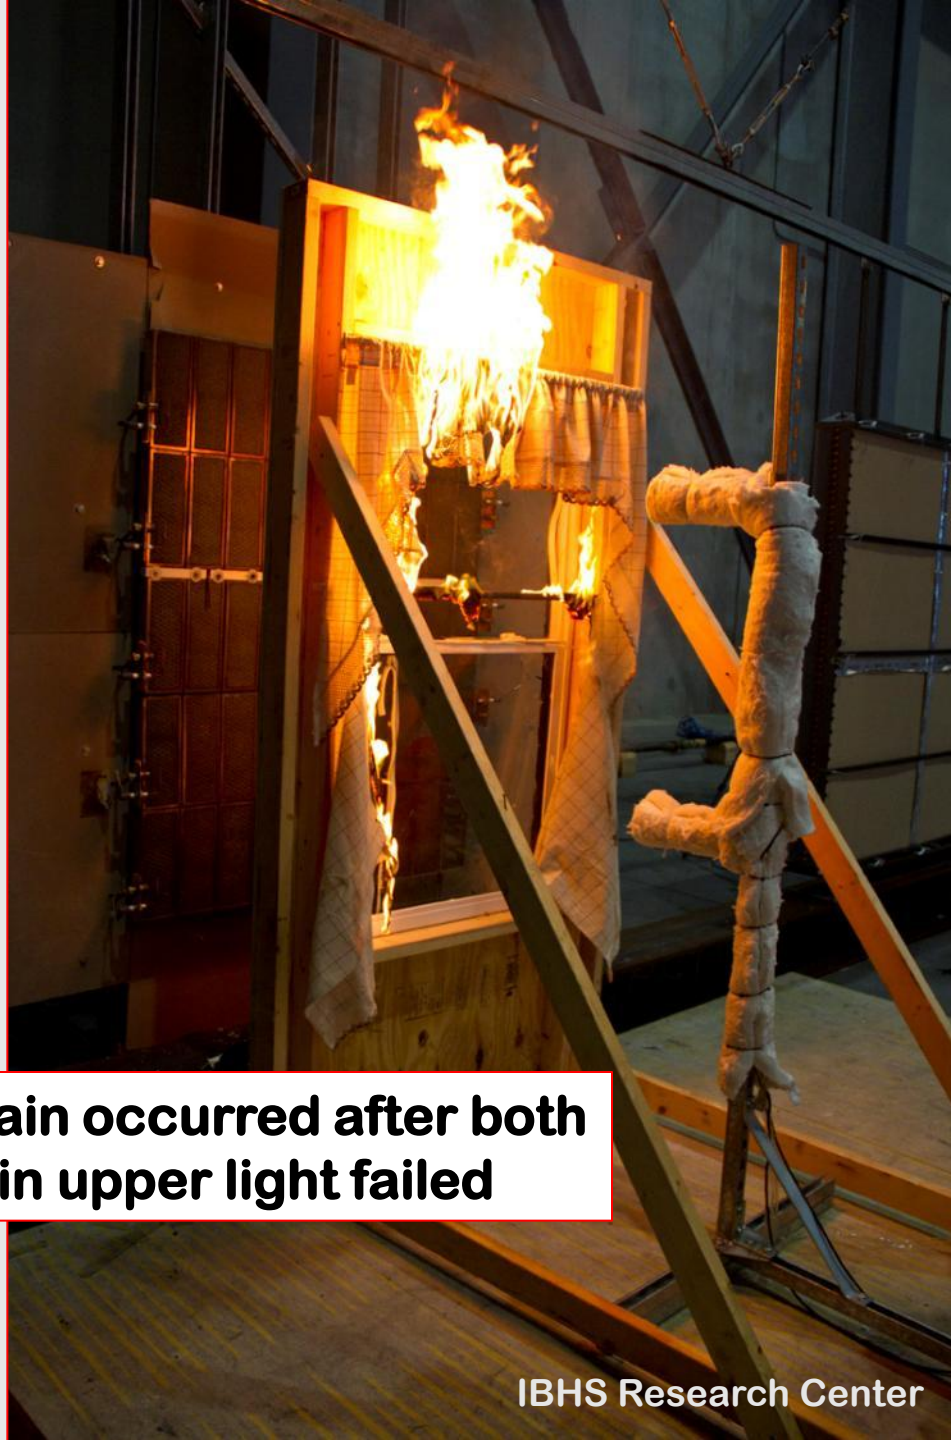
Ignition of curtain occurred after both panes of glass in upper light failed

100% cotton curtain behind dual pane annealed glass, vinyl window

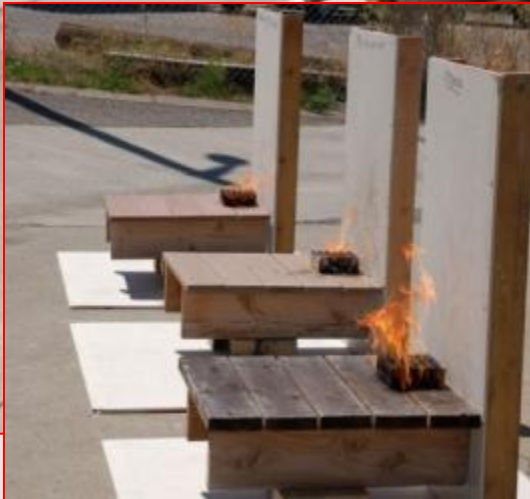
Water staining on bottom of (wood plastic composite) deck boards

Long term performance of joist and wood and joist hanger?

Performance related to decking

WPC, not 7A compliant

'7A' compliant

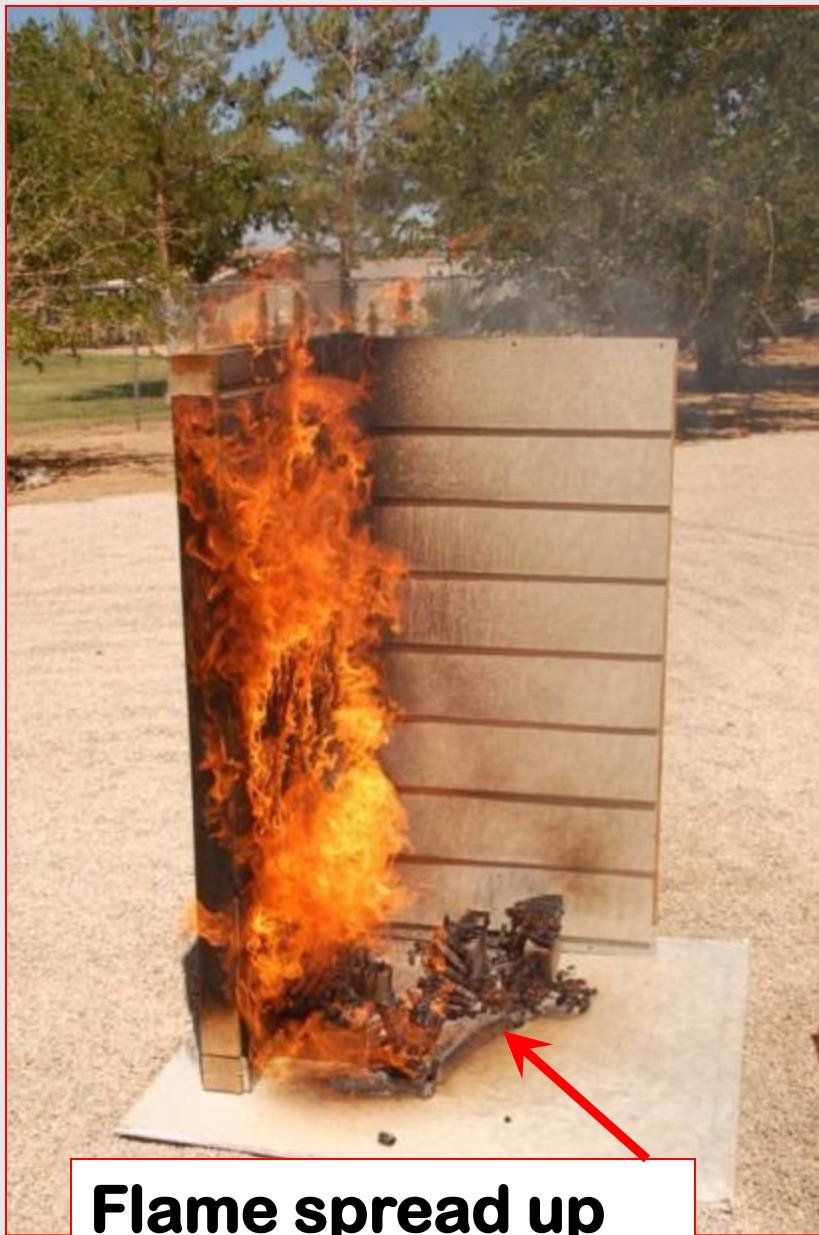
**Flame spread up
the wall ...**

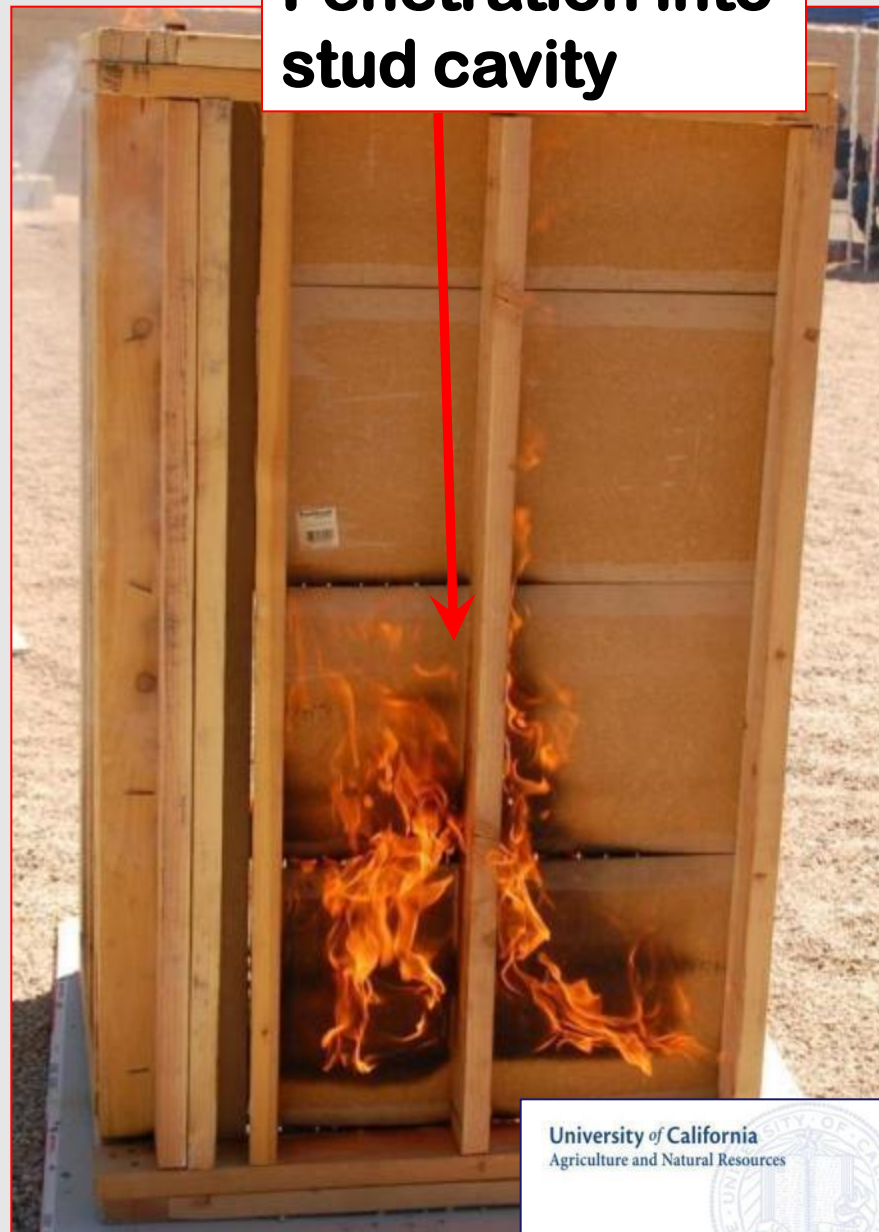
**Penetration into
stud cavity**
